## Case Study - Petroleum Production Scale in the Recycled Water Line

**Customer:** Natural gas and oil producer in Nikiski, Alaska, USA.

**Application:** Offshore petroleum production operation. The device was installed on a 4.5" outer diameter recycled water pipe, after the separator.

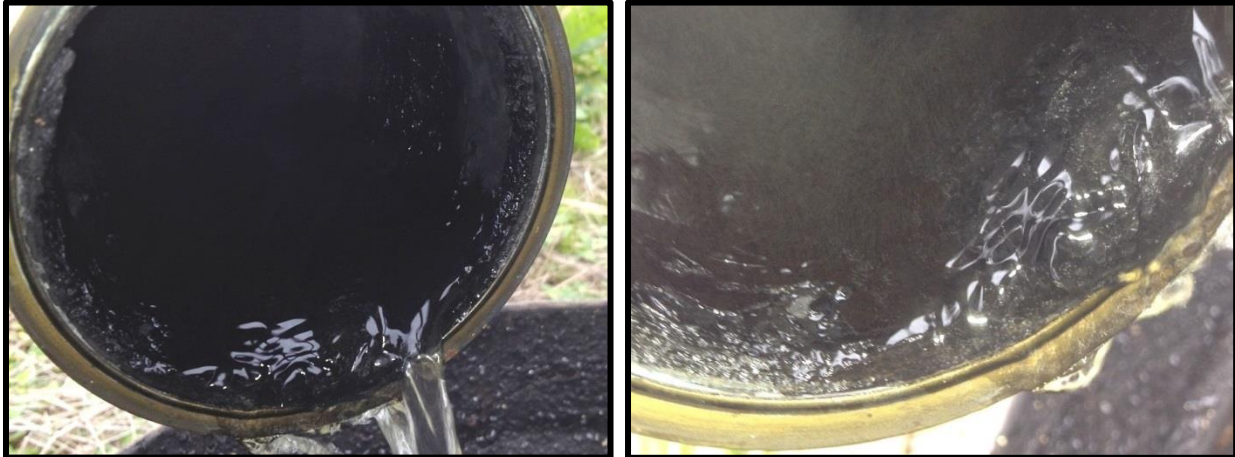
**Installation - October 17, 2013**

Baseline - Hard scale of roughly 1/2" along the inside of the pipe. The scale is dark because it is a mix of iron (predominantly), magnesium, calcium carbonate, silicon and other minerals.

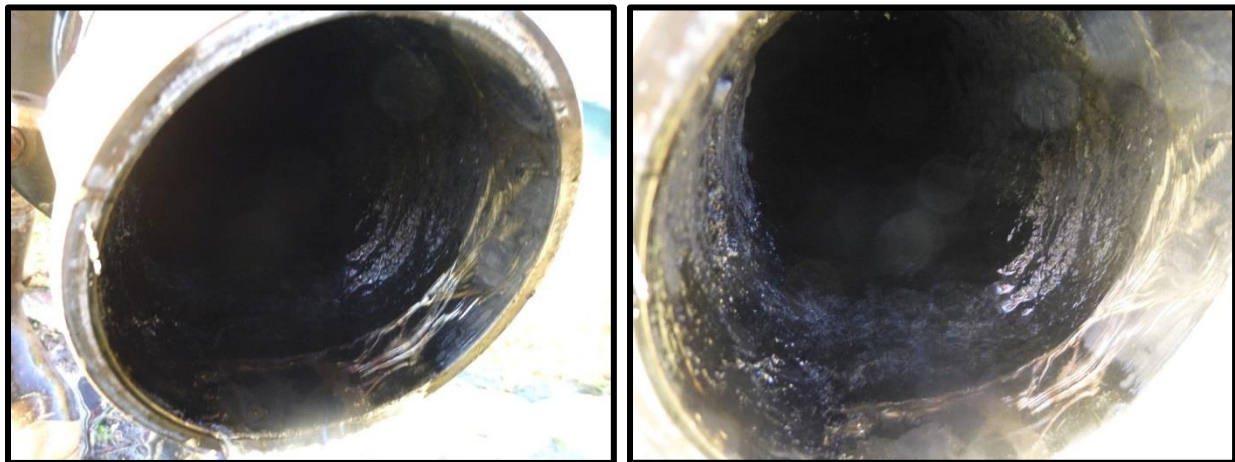
**First inspection - October 23, 2013**

One week after the *HydroFLOW* 120i was installed - The scale was much softer and easily removed with a knife. A ring was cleaned in order to determine if scale will not accumulate on a clean surface as long as the 120i is in operation.

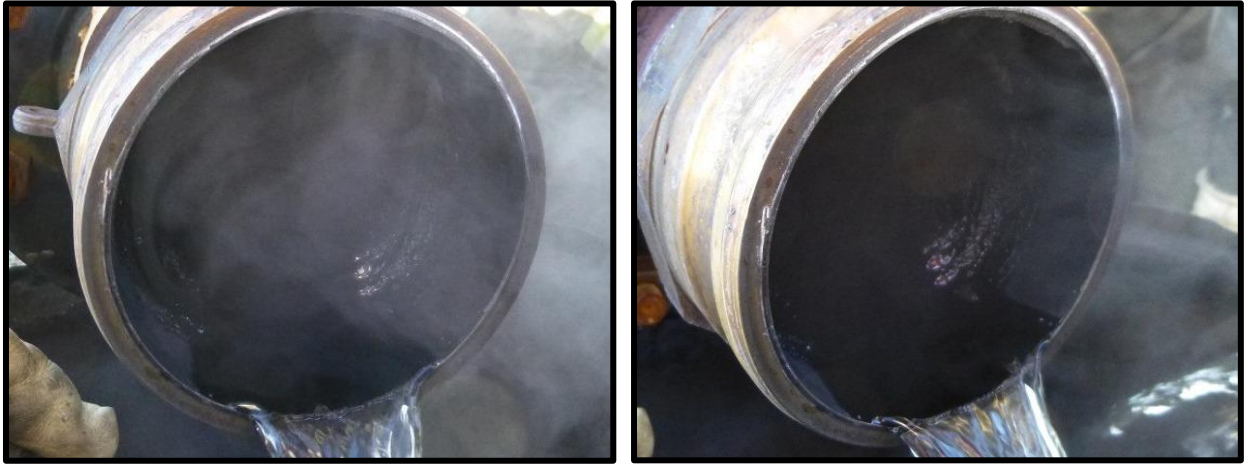
**Second inspection - November 18, 2013**

One month after the *HydroFLOW* 120i was installed - Apart for what seems like a thin magnetite layer, hard scale is not accumulating on the area that was cleaned after the first inspection. Existing scale can be flaked off with a finger and is roughly 1/8" to 1/4" thick. The customer's personnel were very surprised because typically removal of scale involves hard manual labor.

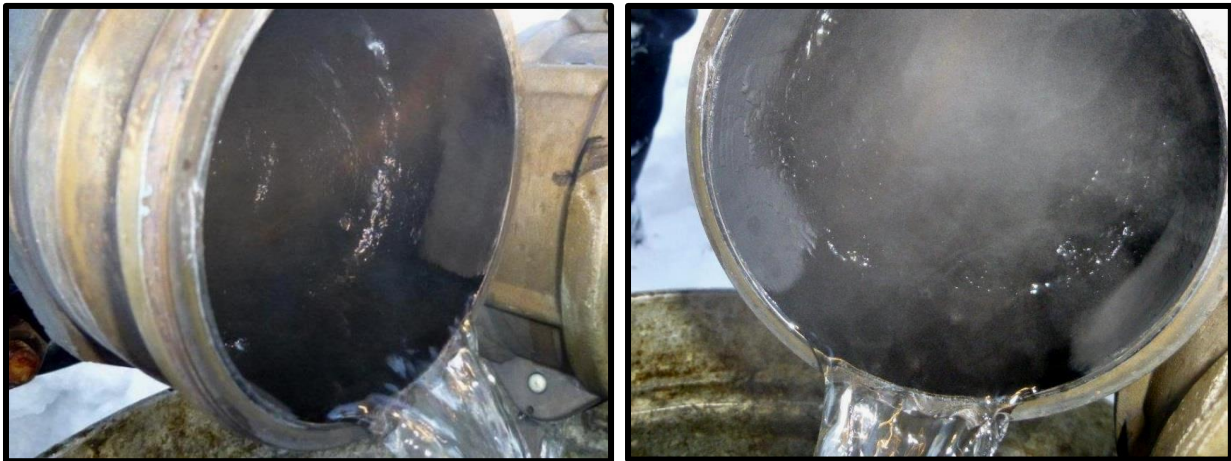
**Third inspection - December 30, 2013**

Two months after the *HydroFLOW* 120i was installed - Hard scale is not accumulating on the area that was cleaned after the first inspection. Existing scale can be easily flaked off.

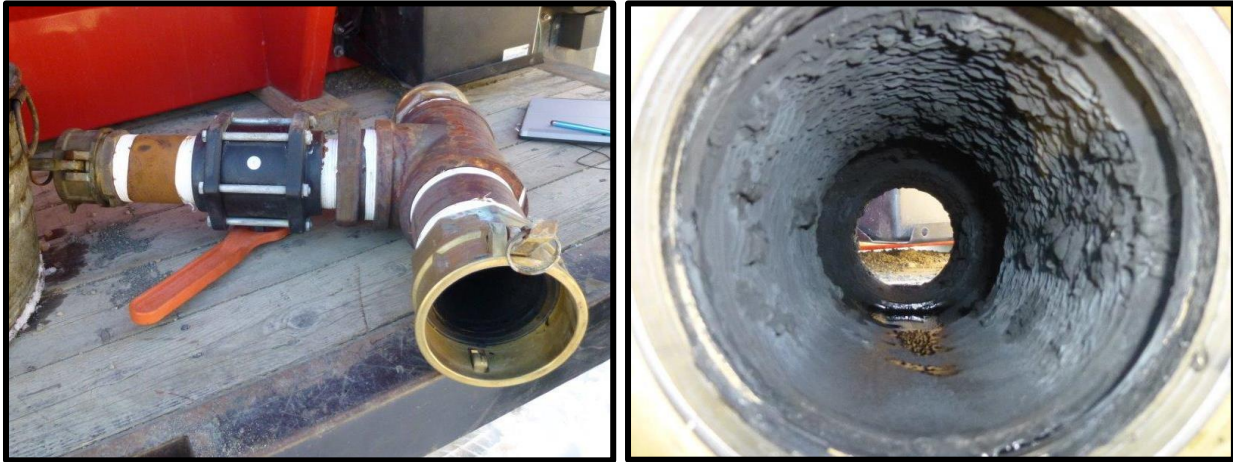
### Third inspection - Additional observation

A "T" section was removed from the main line in order to inspect the inside of the pipe. It was noticed that the rate of scale removal from the bottom was much faster than the top and sides. The reason for this is because the bottom of the pipe has constant flow of water which allows scale to be removed more efficiently.
