Case Study - Waste Water Treatment Plant - Struvite

Four Month Evaluation of Hydropath Technology's ability to treat magnesium ammonium phosphate (struvite)

Updated on: September 20, 2013

Location: City of Walla Walla Waste Water Plant (Washington State, USA).

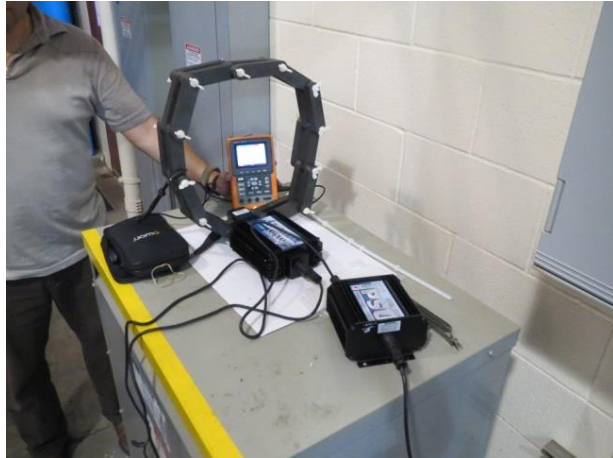
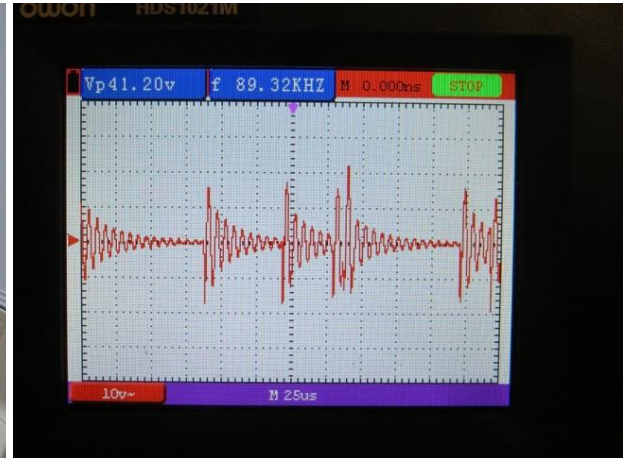
Bench test of P12" device prior to installation - Average of 41.20 volts peak-to-peak and strong Hydropath signal.

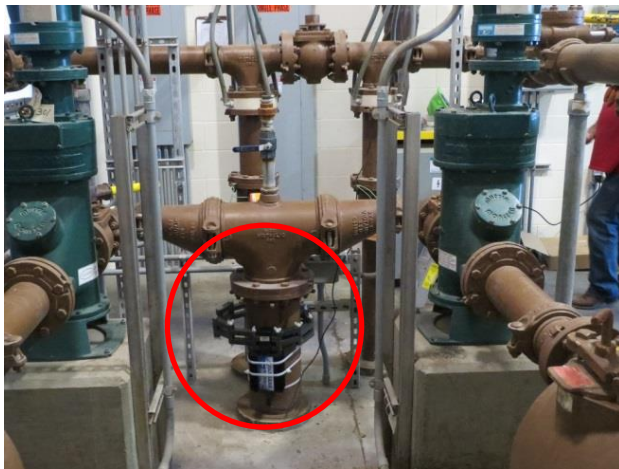
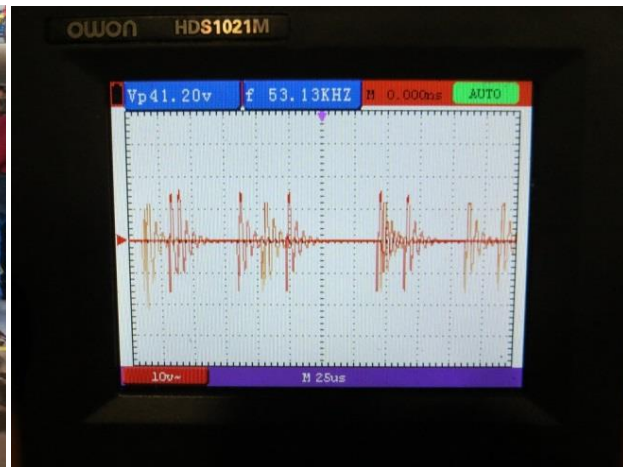
Installed *HydroFLOW* P12" device - Average of 41.20 volts peak-to-peak and strong Hydropath signal.

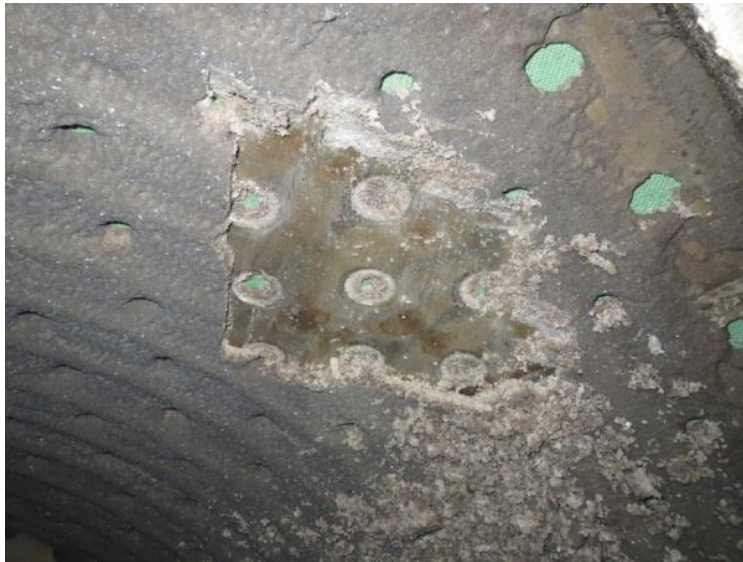
May 31, 2013: A 12" X 12" section was scraped clean inside the roll. The struvite accumulation was very hard and needed to be removed with a chisel.

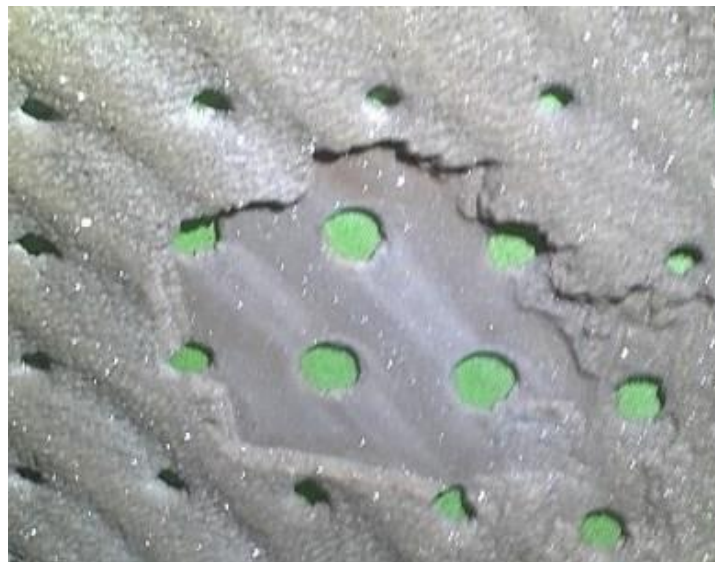
July 9, 2013 (HydroFLOW on for 5 weeks): No accumulation on 12" x 12" section. Struvite removal is slow yet noticeable

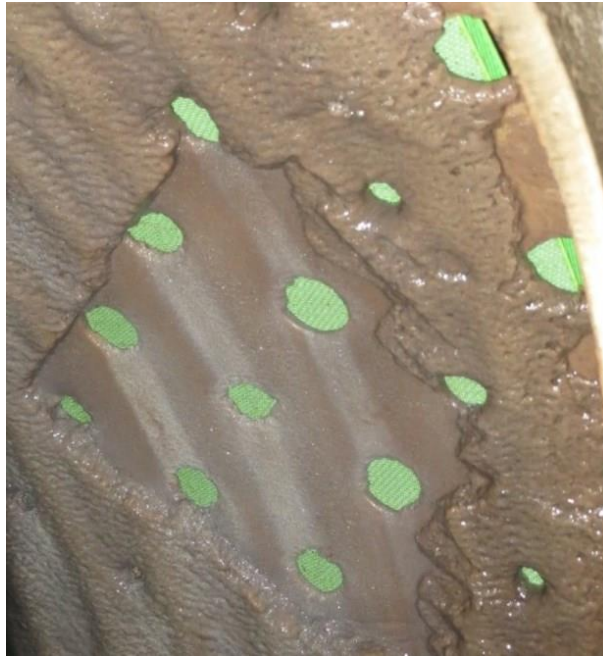
July 25, 2013 (HydroFLOW on for 8 weeks): No accumulation on clean section and struvite layers being gradually removed.

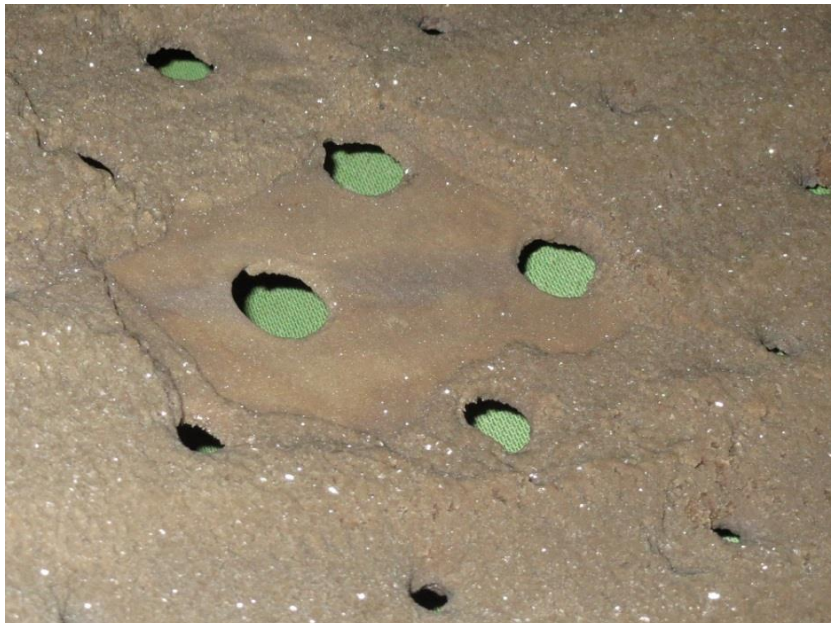
August 26, 2013 (HydroFLOW off for 4 weeks): The HydroFLOW device was turned off in order to demonstrate struvite accumulation without it. Please note that precipitated minerals tend to attach to existing deposits, which explains why the accumulation is spreading from the edges to the center of the 12"x 12" section.

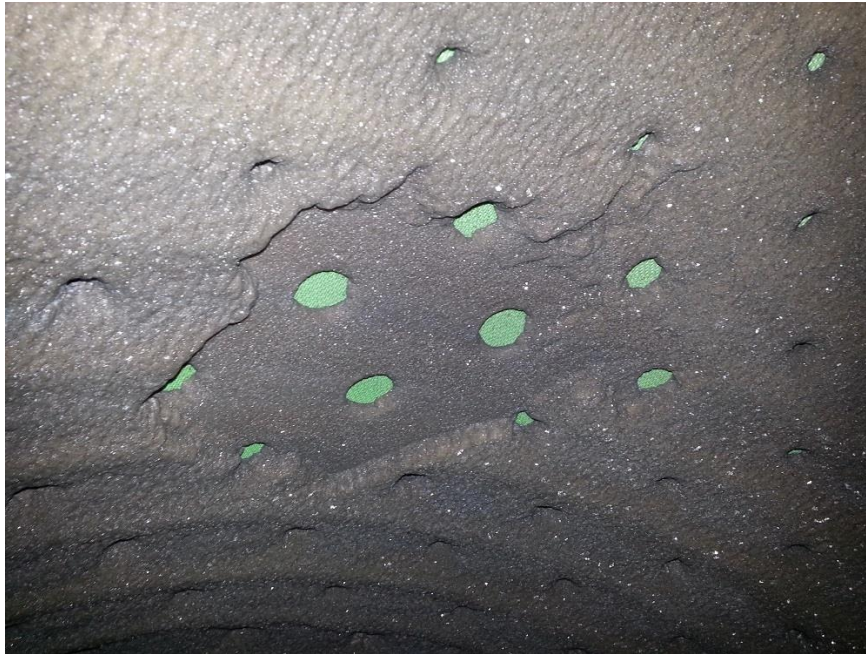
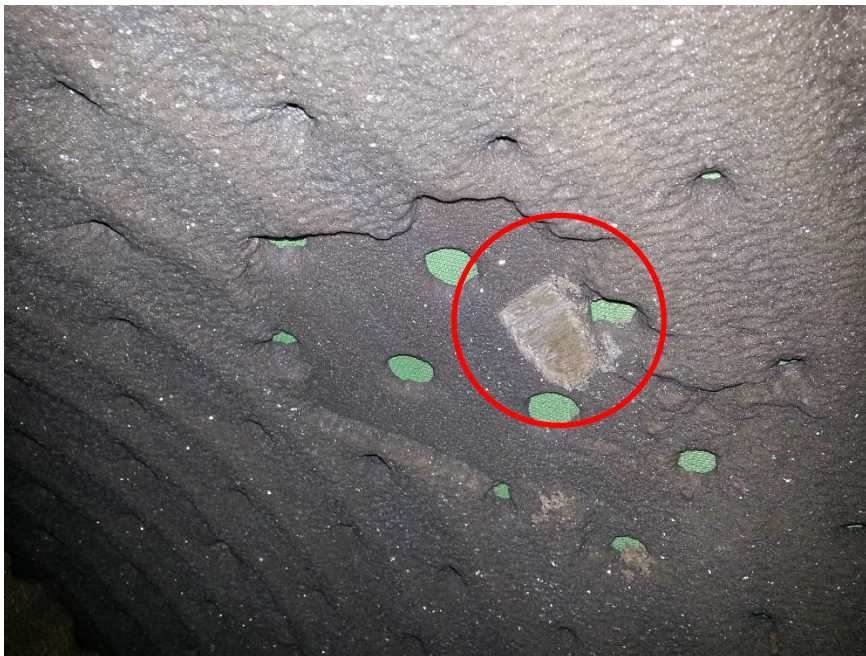
September 18, 2013 (HydroFLOW off for 7 weeks): The cleaned section is completely covered with a very hard struvite layer of 1/8". The a small section was chiseled in order to expose bare metal.

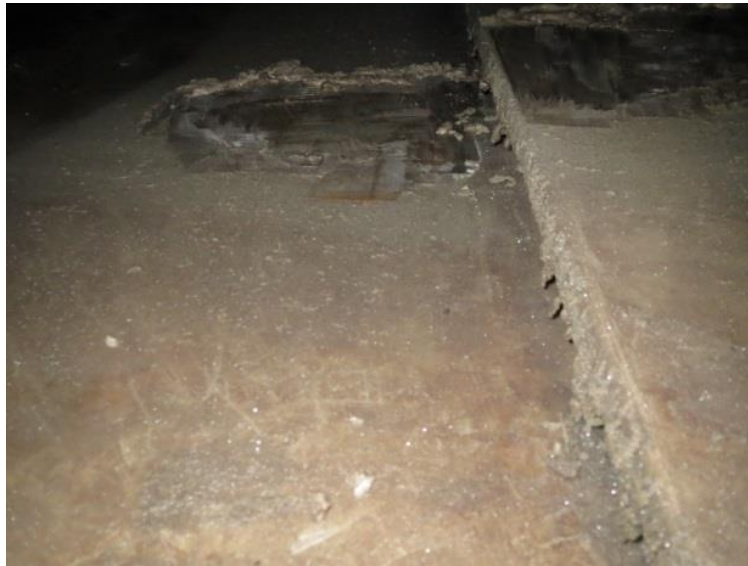
May 31, 2013: A 12" X 12" section was scraped clean on the pan. The struvite accumulation was very hard and needed to be removed with a chisel.

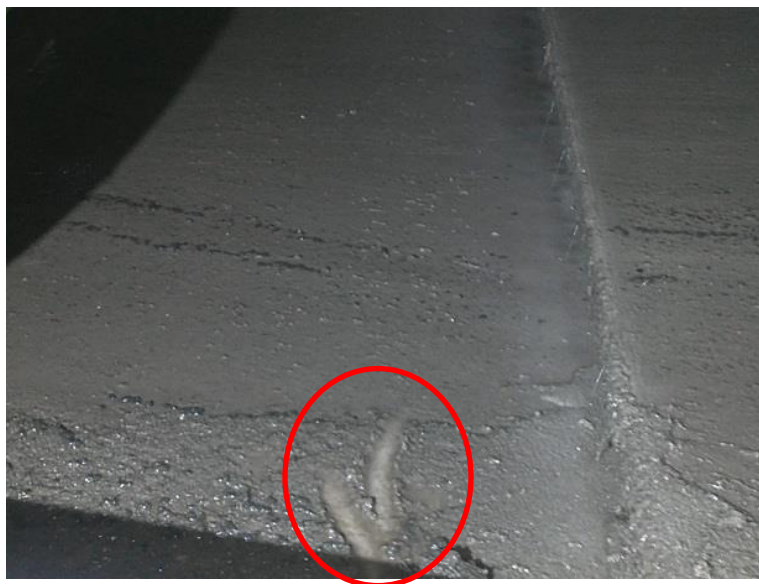
July 9, 2013 (HydroFLOW on for 5 weeks): The 12" x 12" section is not noticeable. The struvite deposits are very soft. The below picture shows finger marks in order to depict the softness of the mineral deposits.

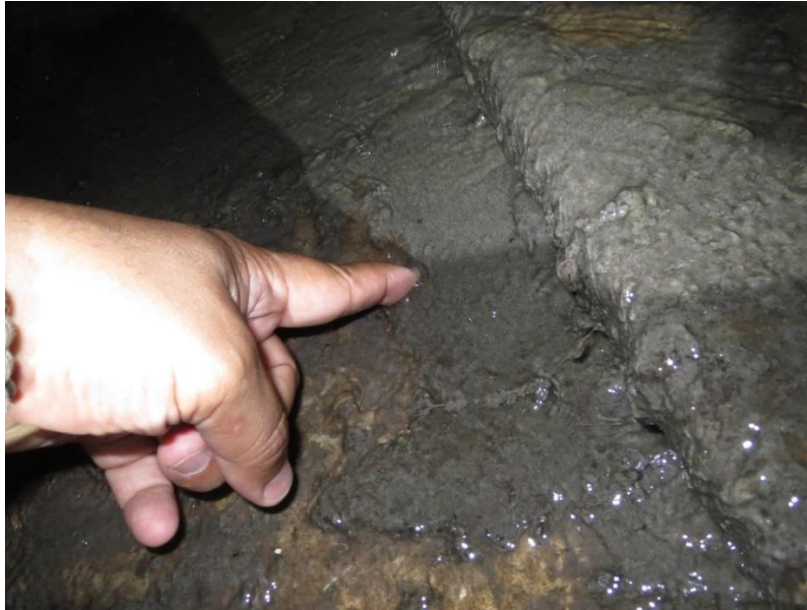
July 25, 2013 (HydroFLOW on for 8 weeks): The struvite deposits are soft and can be washed off easily with a hose.

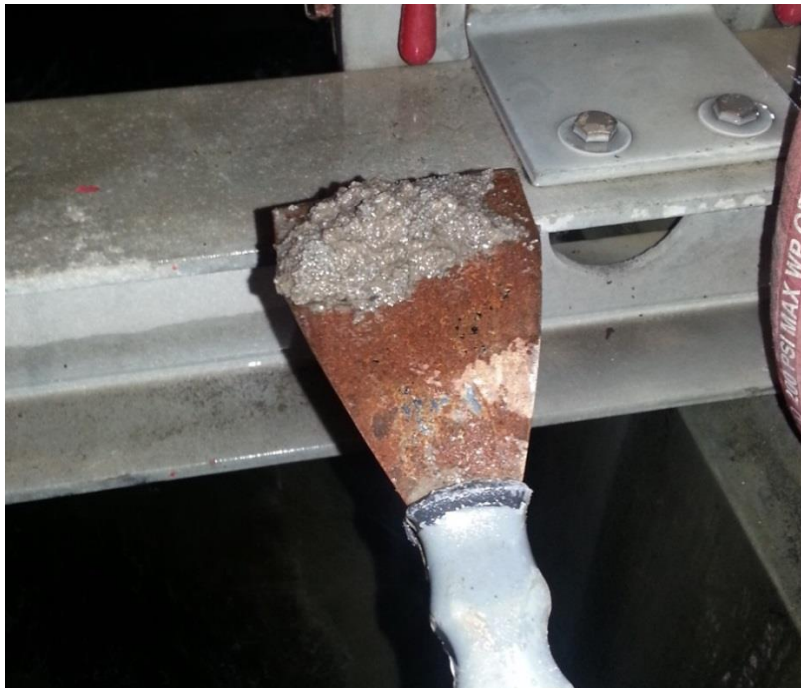
Soft struvite “paste” that was removed from the pan.

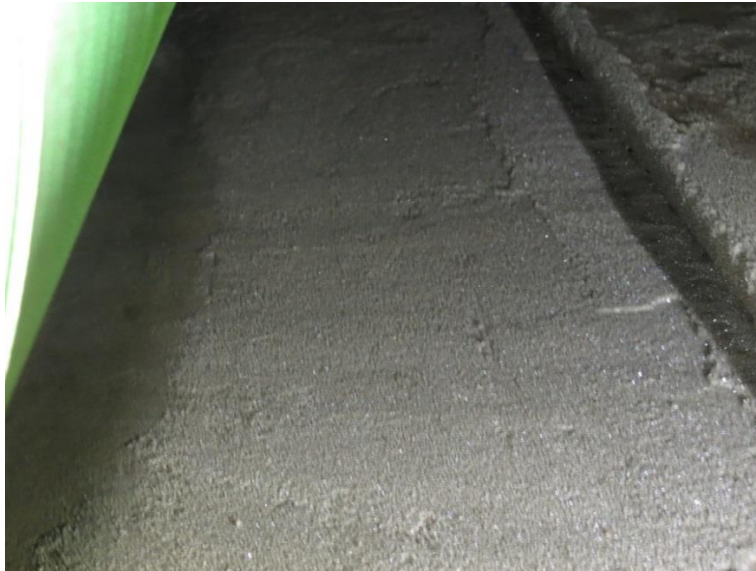
August 26, 2013 (HydroFLOW off for 4 weeks): The *HydroFLOW* device was turned off in order to demonstrate struvite accumulation without it. A 1/8" layer of medium hardness struvite accumulated within 4 weeks. The struvite is not as hard as inside the roll section.

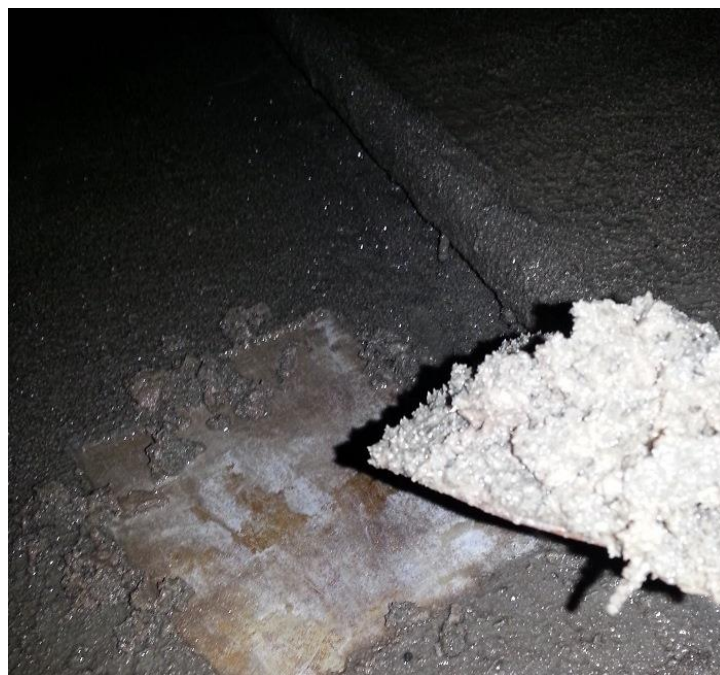
September 18, 2013 (HydroFLOW off for 7 weeks): A 1/4" layer of medium hardness struvite accumulated within 7 weeks. The struvite is not as hard as inside the roll section. It can be scraped but not washed off.
