# **MV Hoegh Antwerp Report**

Ray Car Carriers Ltd. Stamco Ship Management Ltd., Piraeus, Greece

Prevention of limescale buildup inside the heat exchange plate of a Fresh Water Generator (FWG)

June 26, 2015

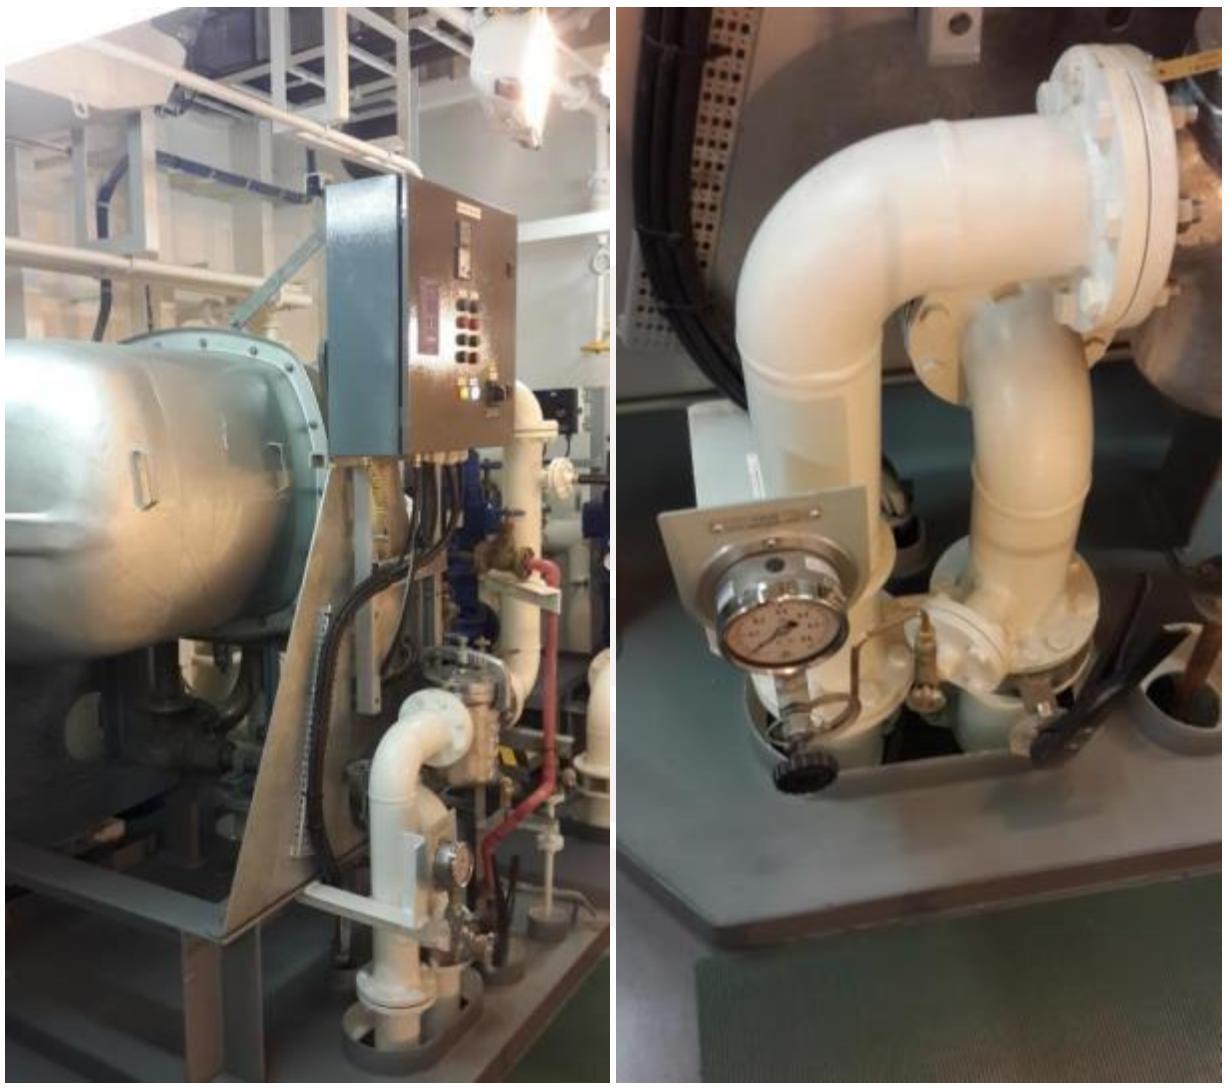
The FWG has an inlet and outlet pipes next to it, but there was no room to install the HM unit close to the FWG. Therefore we followed the inlet pipe backwards to a lower level and found the closest location for installation (approx. 10m from the FWG).

Figure 2. The Fresh Water Generator with its inlet and outlet pipes (inlet is the right pipe on the right photo)

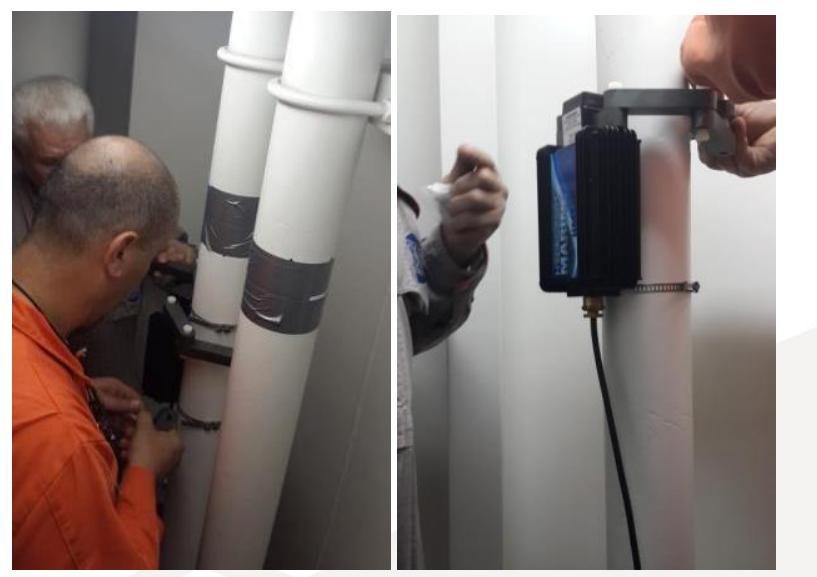
Figure 3. Installation location

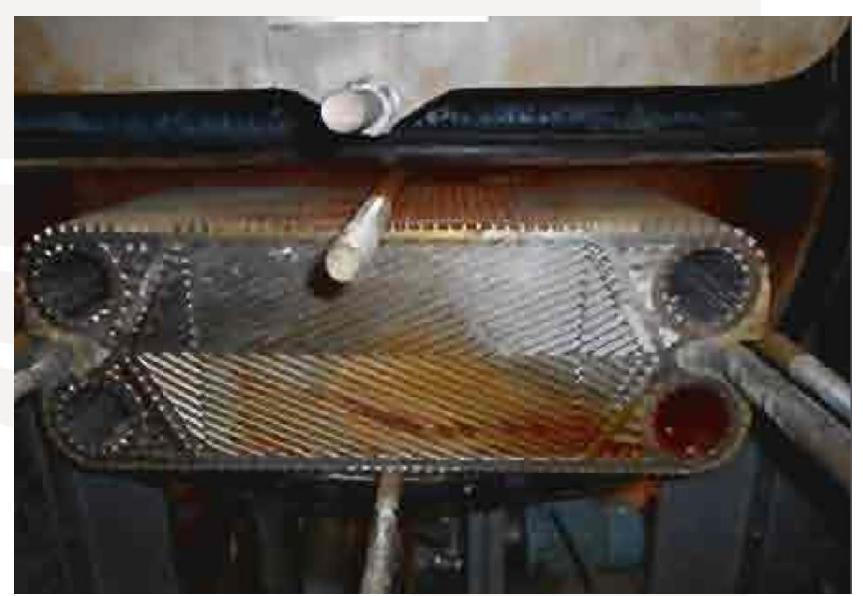
Since installation date January 2014 to June 26, 2015 there was no reduction in water production of the FWG, and it is working in full capacity **without chemical treatment and without opening** for cleaning.

The FWG was opened for inspection on June 26, 2015 (After 18 months) although water production was not

reduced (20.5 mt/day). The reason for opening was only

Figure 4. FWG plates on inspection date – June 26, 2015

in order to inspect the efficiency of the Hydropath Marine treatment and its results. No lime scale buildup was found during opening and no chemicals were required for cleaning. The plates were washed with water and put back into the chamber.

Therefore it is clear that the Hydropath Marine unit is successfully treating limescale buildup inside the FWG.
