HydroFLOW Case Study - Medical Center Steam Boiler

Customer: Medical Center in Florida.

Equipment: Sussman ES135 Electric Steam Boiler.

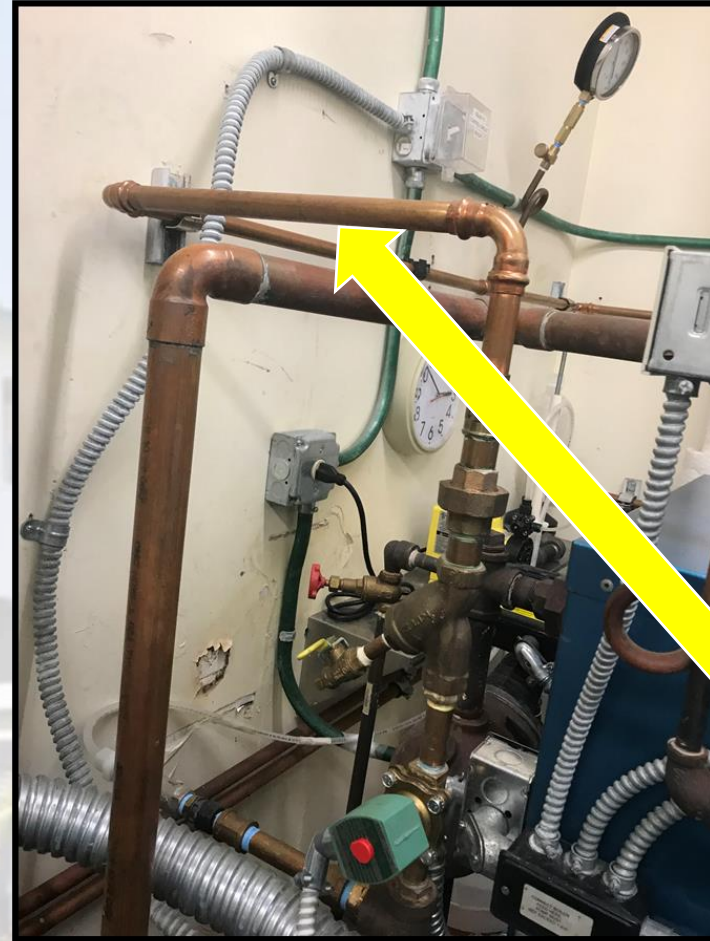
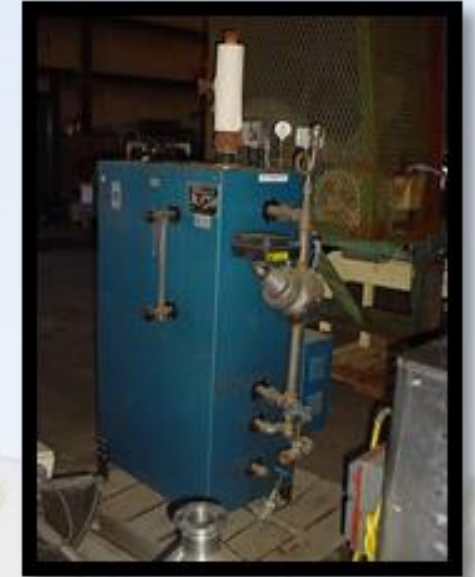
A *HydroFLOW* i60 unit was installed on the copper incoming cold water pipe feeding the boiler

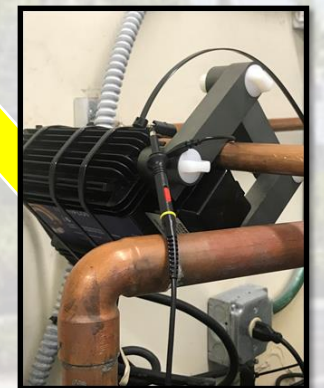
Sussman ES135 Electric Steam Boiler

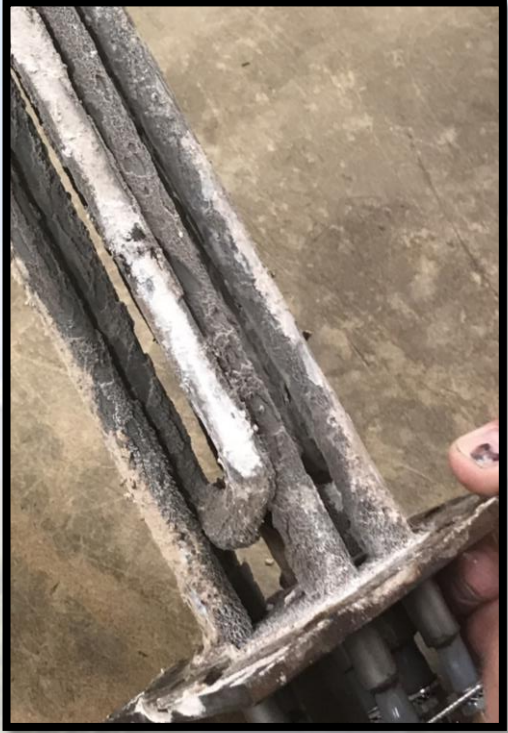
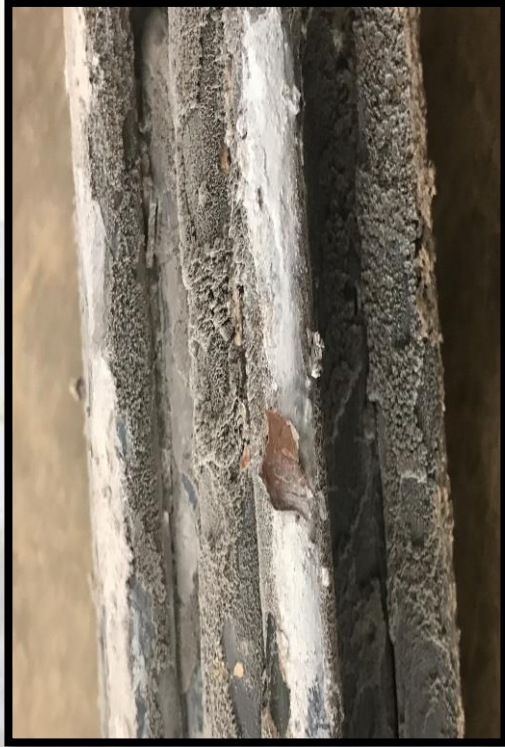
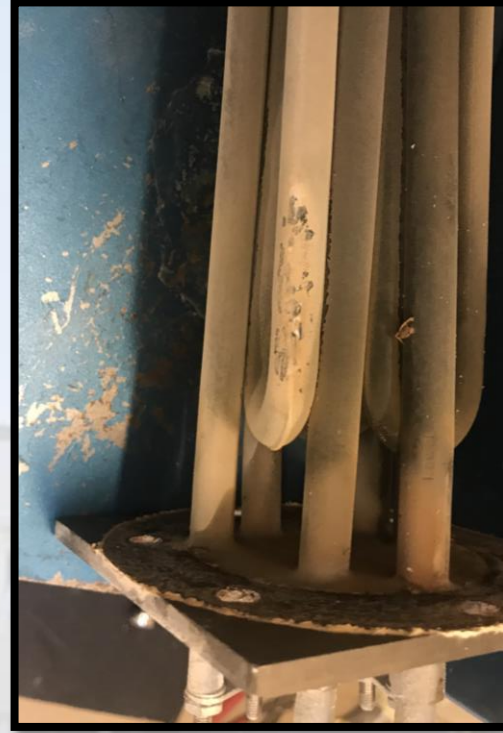
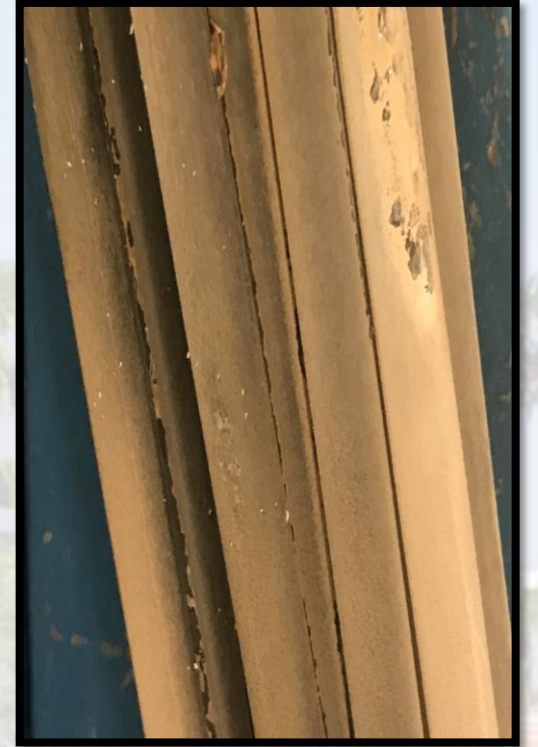
Before and After Photos

After 60 days, there was no new scale accumulation and existing hard scale was removed.

- The *HydroFLOW* i60 successfully prevented hard scale accumulation on the heating elements and inside the heating chambers.
- The *HydroFLOW* i60 removed existing hard scale deposits from the heating elements and heating chambers.
- Some scale deposits were still observed but they were in the form of very loose powder that did not impede water flow or heat transfer efficiency.
- An impressive payback period of 16 months was achieved.
