## Heat power station steam condenser protection from biofouling

**Let us consider a case study how AquaKlear is used for heat power station steam condenser protection from biofouling.**

**Application:** Steam condenser protection from bio-fouling.

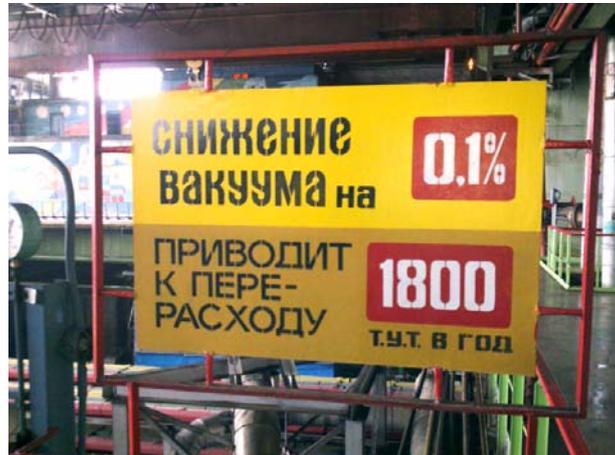
Placard in heat power station turbine workshop.

The text is: 0,1% vacuum loss cause excess 1800 tons of standard coal fuel

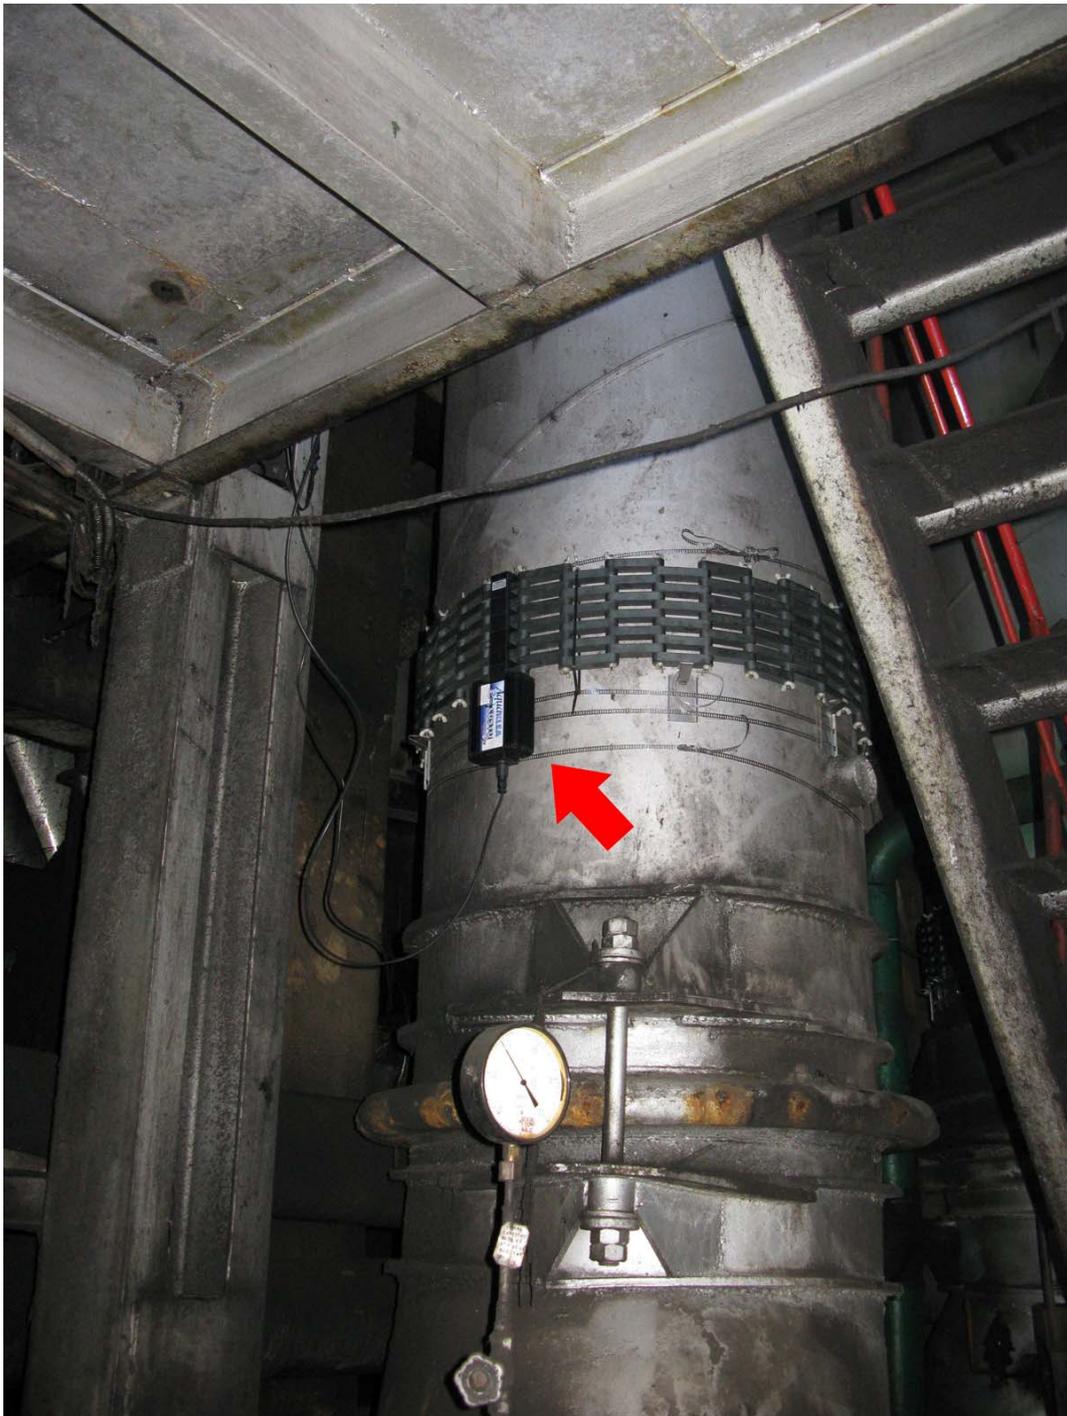
AquaKlear Custom P-40” is installed on a pipeline.

**Units:** AquaKlear Custom P-40" x 2 pcs., main pipes are 1000 mm each.

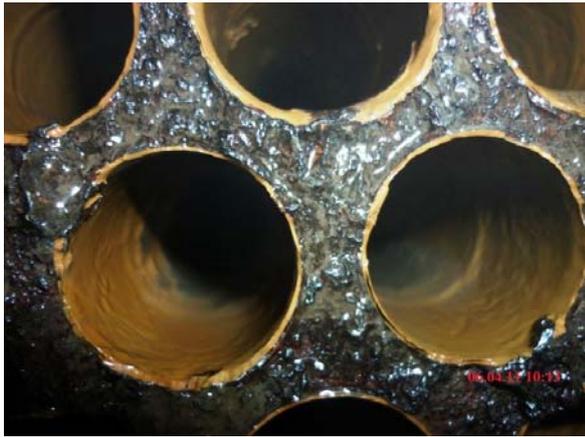
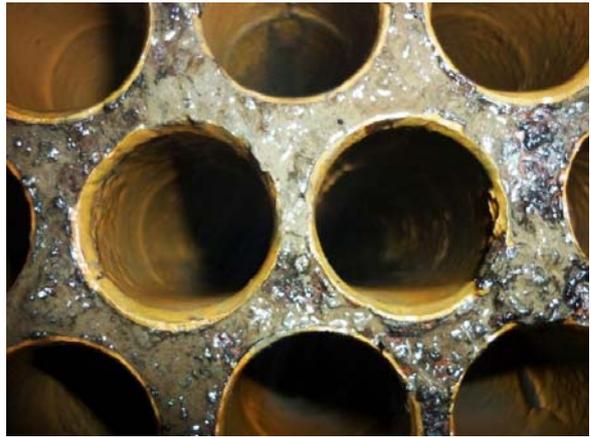
**Condenser with AquaKlear, July 2011.**

Inlet chamber, bottom

**The following was found in the condenser with the AquaKlear:**

- The inlet chamber of the tube bundle partially contained foreign matters (wood chips, plastic parts);
- The internal surfaces of tubes have silt deposits. Characteristics of deposits – soft, can be washed out with the water. On most of the tubes there can be seen a characteristic metal glitter (brass), which indicates cleanness of the surface;
- Properties of deposits in the outlet chamber are similar to that of the inlet chamber, and the brass glitter can also be seen here;
- A characteristic smell of organic decomposition is absent.

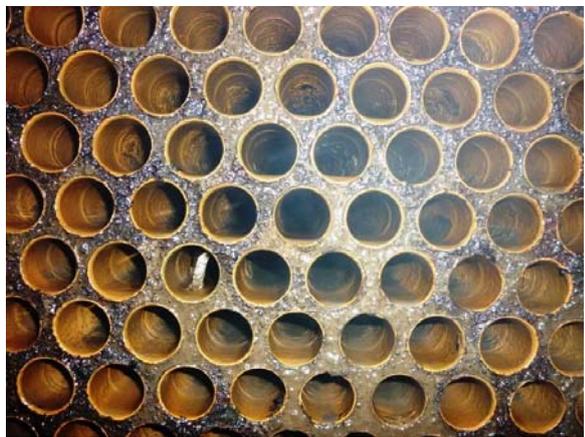
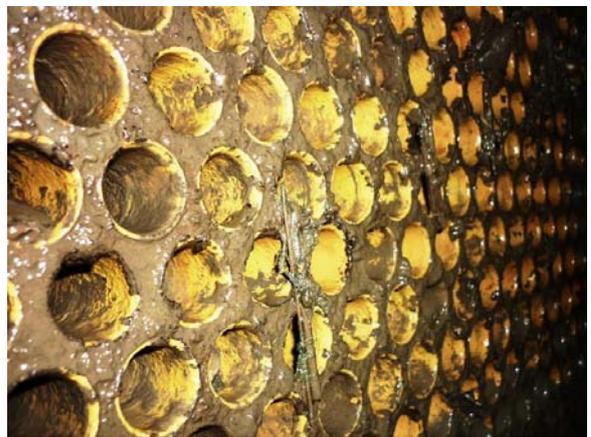
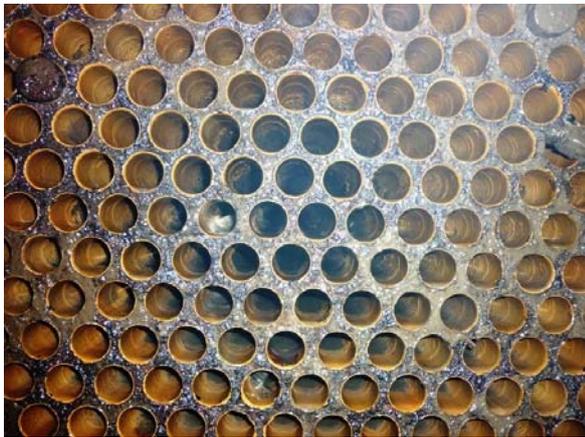
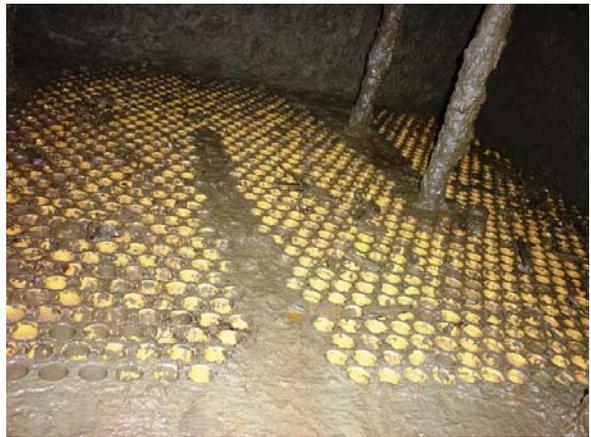
Outlet chamber, top

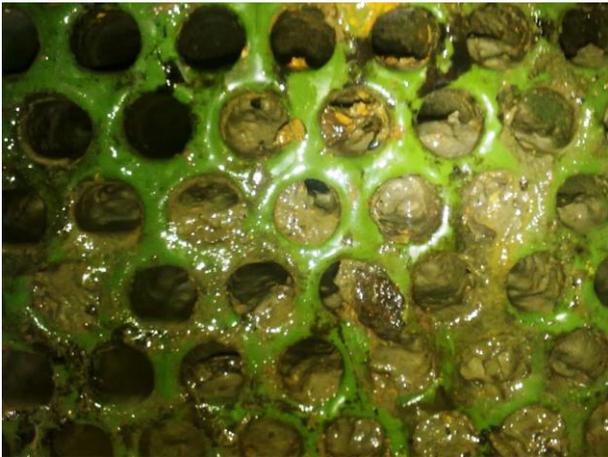
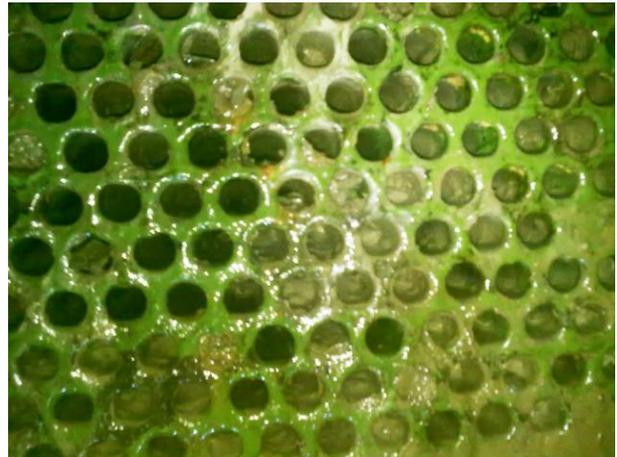
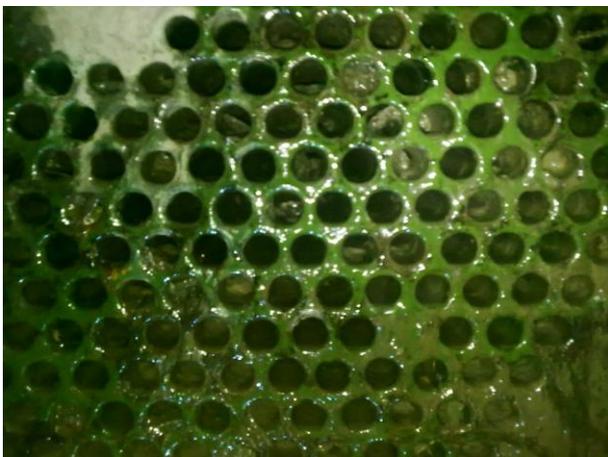
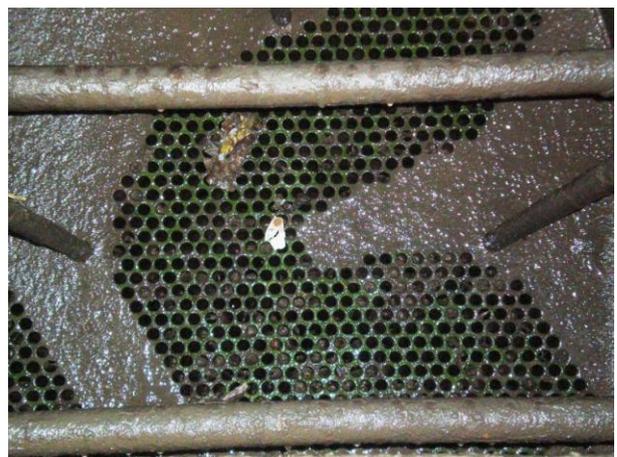
**Condenser of another power-generating unit (without AquaKlear), July 2011.**

Inlet chamber

**In another power-generating unit condenser the following was found:**

- Inlet chambers of the tube bundle partially contained foreign matters (wood chips, plastic parts).
- Internal surfaces of tubes have deposits. Characteristics of deposits – supposedly, it is river mud.
- The tube bundle have tubes with 100% clogging.
- The number of tubes with 100% clogging is about 10-15% of their total quantity;
- Condenser chambers have strong smell, characteristic for organic materials decomposition.

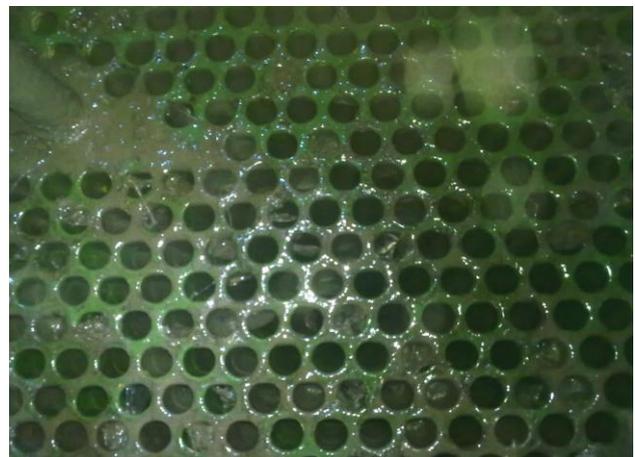
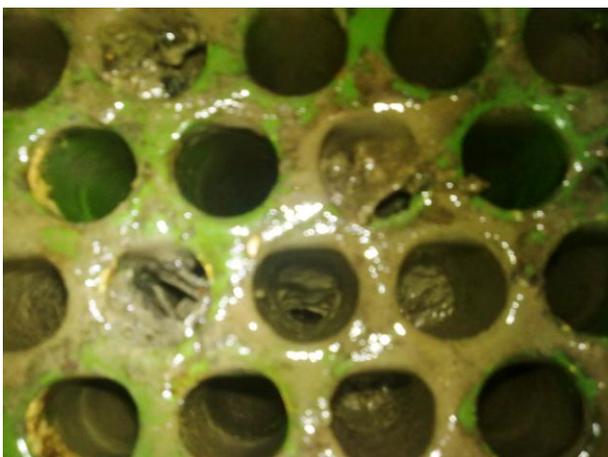
Outlet chamber
