# HydroFLOW Cooling Tower-Chiller Installation

# California Medical Center

Updated on August 23, 2017

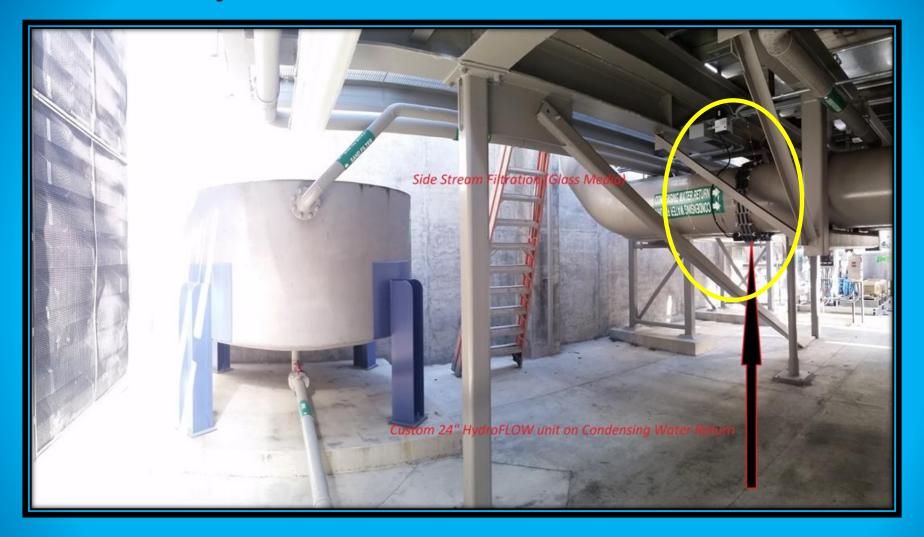
# Custom 24<sup>99</sup> HydroFLOW unit on condenser return line

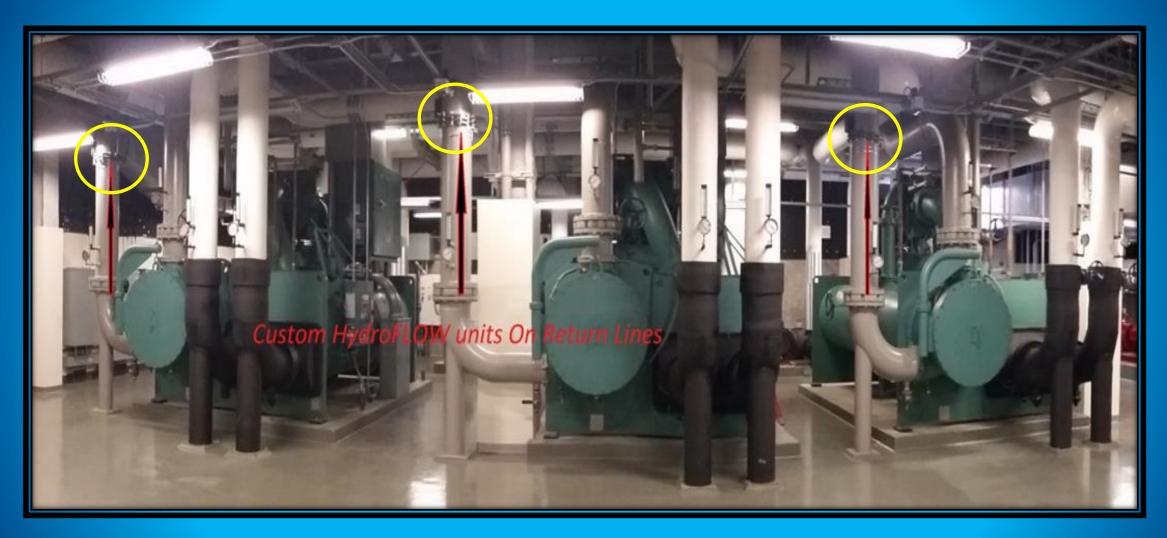
# Custom 14" HydroFLOW units on chillers

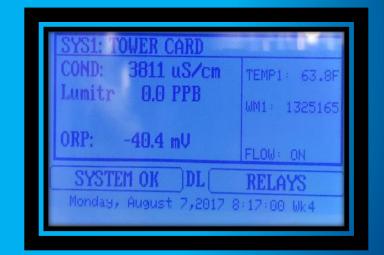
It's important to note that after running at high conductivity for a few months, the sand in the side stream filter was not performing efficiently. It was replaced with glass bead media, which achieved much better results.

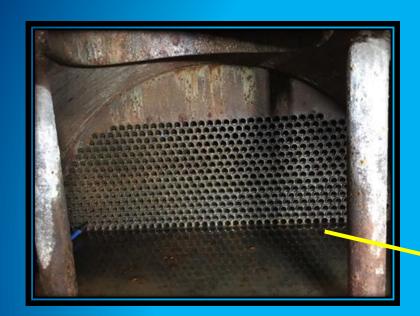
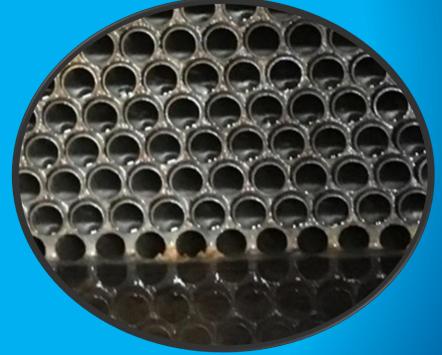
# February 10, 2017 - After 7 month using HydroFLOW

Comment by the Medical Center's head of maintenance at the 7 month chiller tube inspection: "This is the cleanest the chiller tubes had ever been."
