Power Generation Overview in Asia

This document comes to provide a brief overview of the progress made within the power generation sector in Asia.

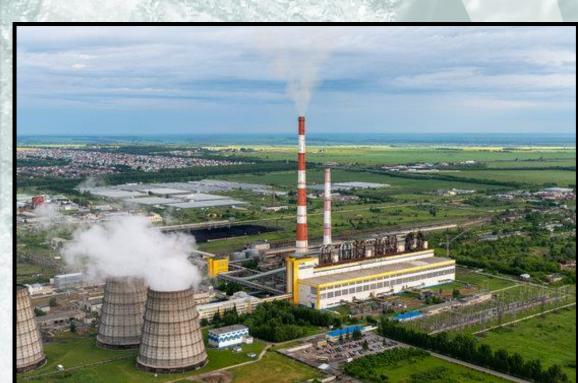
Barnaul Thermal Power Plant #3 - Two custom 40" *Hydro* FLOW units were installed on the pipes feeding the steam condenser. Reduced biofilm accumulation inside the steam condenser was observed.

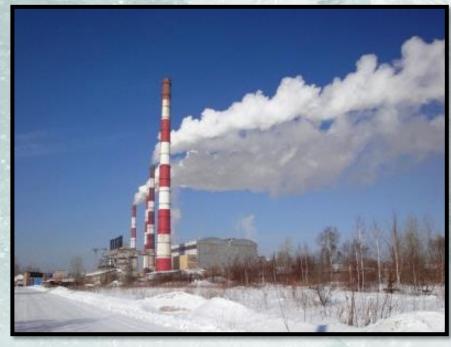
Nazarovsky Regional State Power Station - One custom 56" HydroFLOW unit was installed on the pipes feeding the steam condenser. The power station utilizes untreated river water in its cooling process, which created significant biofilm problems. After a few short months, biofilm accumulation was greatly reduced thanks to HydroFLOW.

After the custom 56" units was installed - Tubes free of biofilm

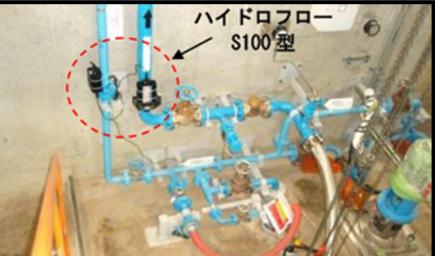
Installed HydroFLOW unit on the line feeding the submersible pump.

Nuclear Power Station in Hokkaido - The cleaning cycle of the submersible pumps was extended from 1.5 months to 12 months.

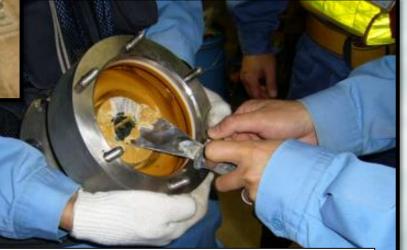
After - Significantly less scale. Remaining scale is softer, and cleaning was extended from 1.5 months to 12 months.

Before - Hard scale in the pump.

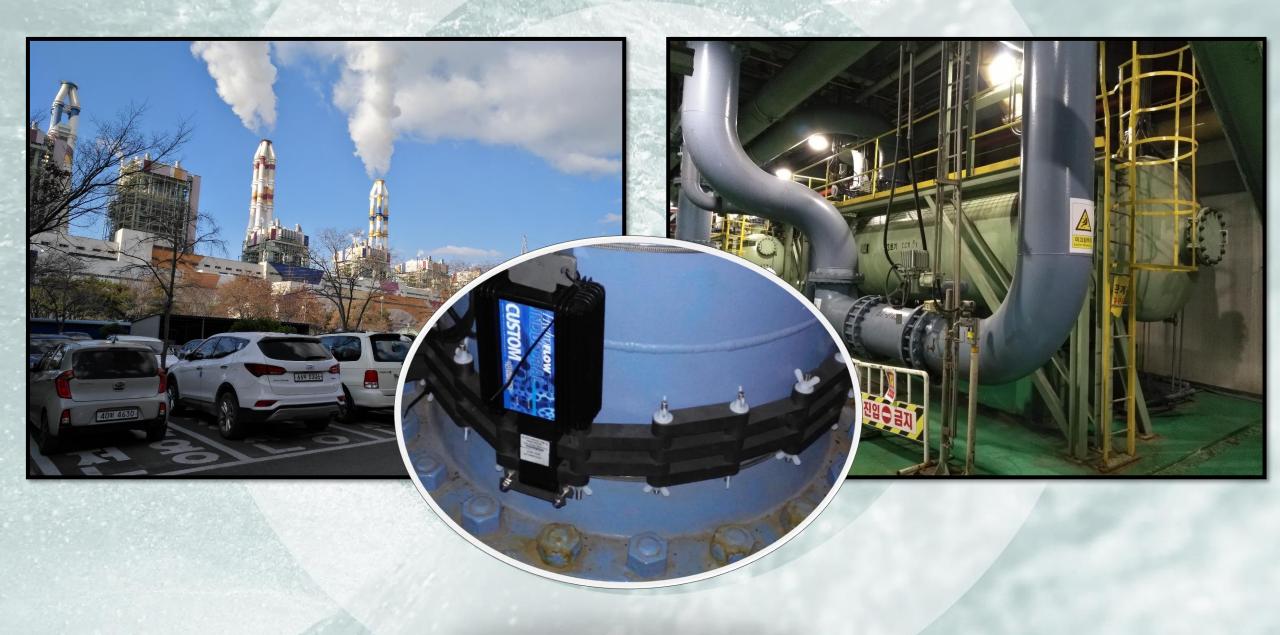
KOEN Power Station - A *Hydro*FLOW Custom 24" unit was installed on a dirty heat exchanger. After 12 months, both delta T and P were still within operation limits. The heat exchanger was opened for inspection and was found to be clean. The client was happy with *Hydro*FLOW's performance and plans to order additional units.

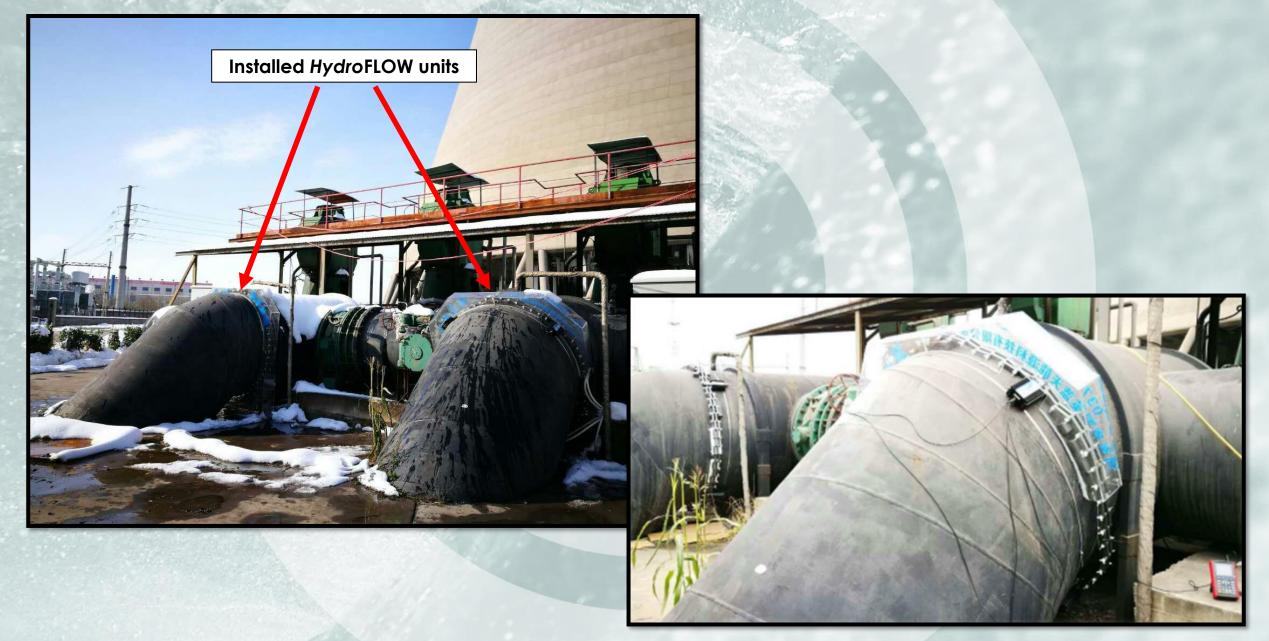
2 x 600 MW coal plant (river water cooled) - Two 72" custom units were installed on the steam condensers. The objectives was to reduce chemical usage and increase efficiency. After one year; anti-scalant chemical were eliminated and biocide dosing was reduced by 90%. The steam condenser transit temperature reduced by 1.5°C and vacuum pressure increased by 1 KPa compared to the same period in previous years. No hard scale was found inside the condenser and cooling tower.

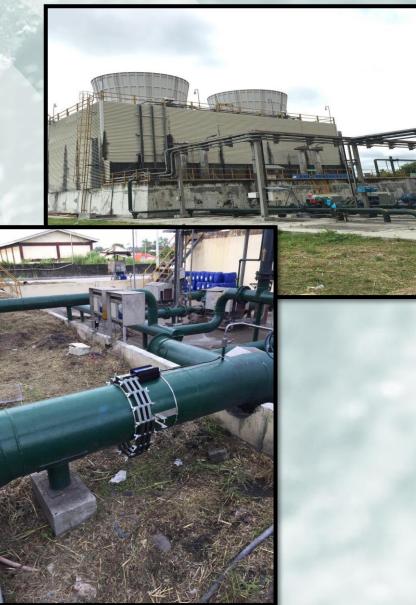
3.5 MW Lamsan Biomass Power Plant - This is a small power plant that uses rice hulls (the protective coverings of rice grains) as fuel. The objectives were to reduce chemical usage and increase heat transfer efficiency. Two HydroFLOW units were installed.

Chemical usage was reduced by 30%.
The heat exchanger's efficiency was maintained within required parameters.
