HydroFLOW Case Study

Screw Press Struvite Treatment

Installed: September 2023 Last Inspection: November 2023

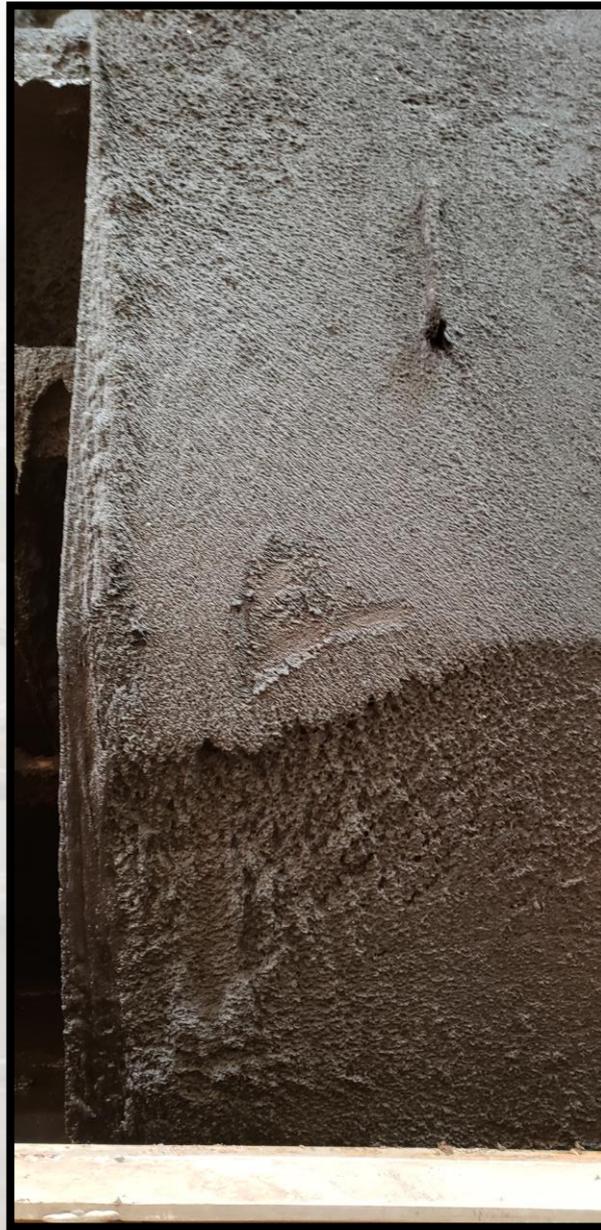
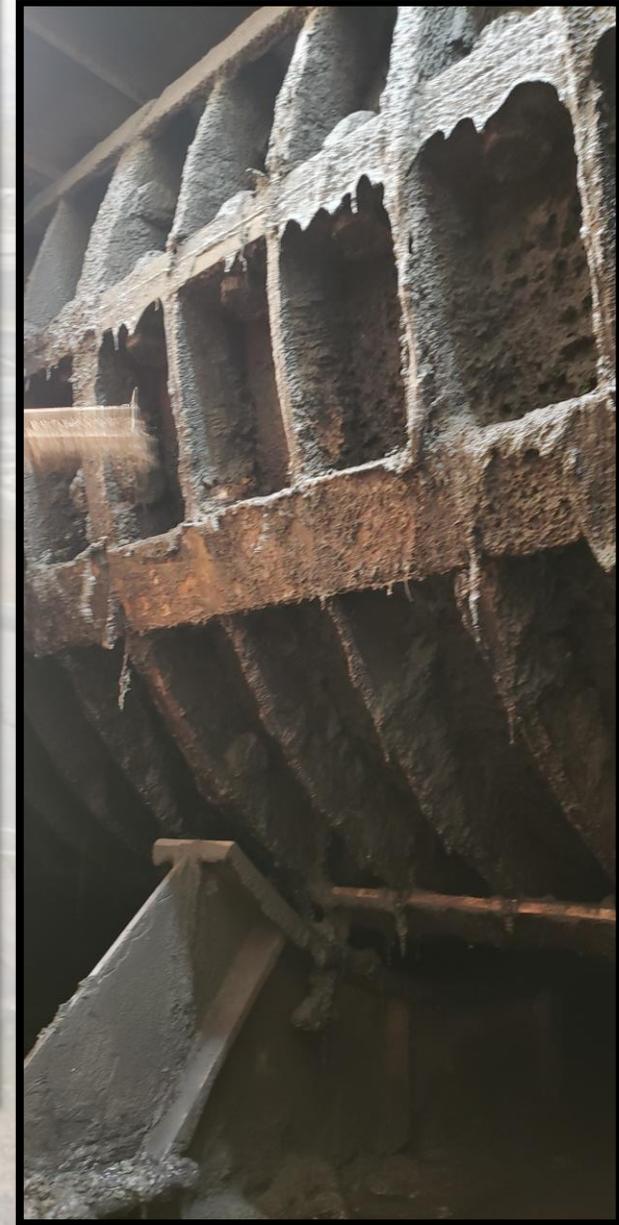
Hard Struvite buildup inside the screw press

Struvite accumulation in the plant's two screw presses is a constant and costly maintenance issue. The plant uses a Struvite reduction chemical costing \$8,000/month. The presses also require monthly cleaning, taking up to 30 hours to complete due to the concrete-like Struvite scale formation.

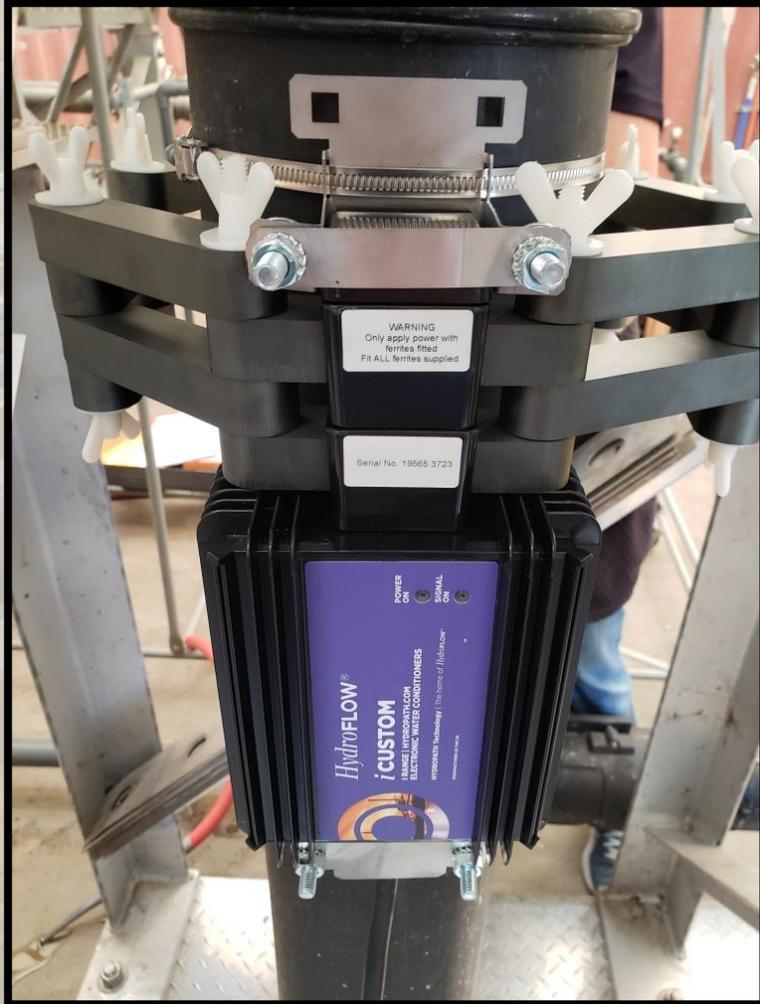
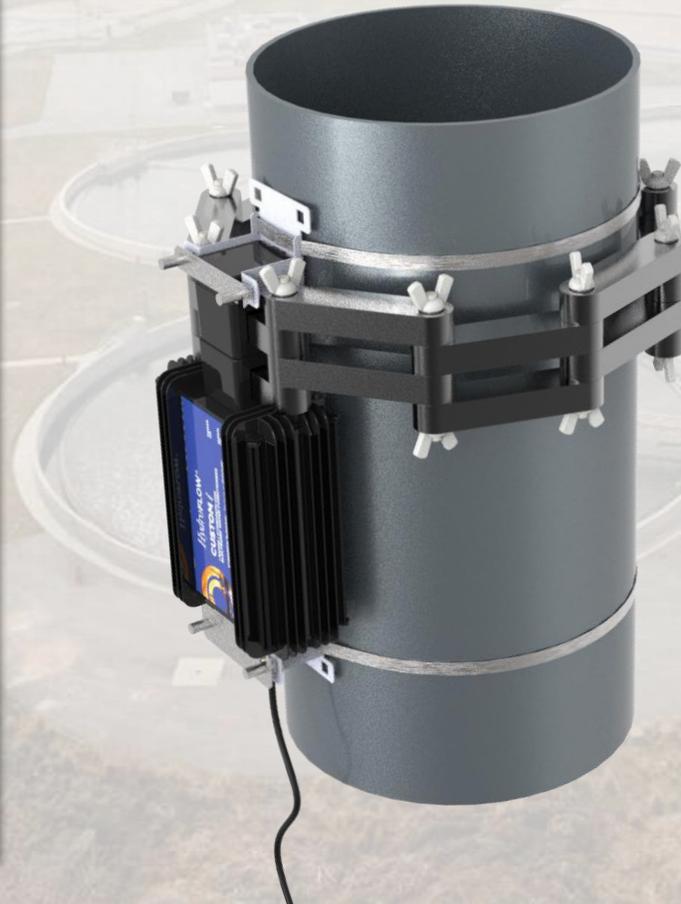
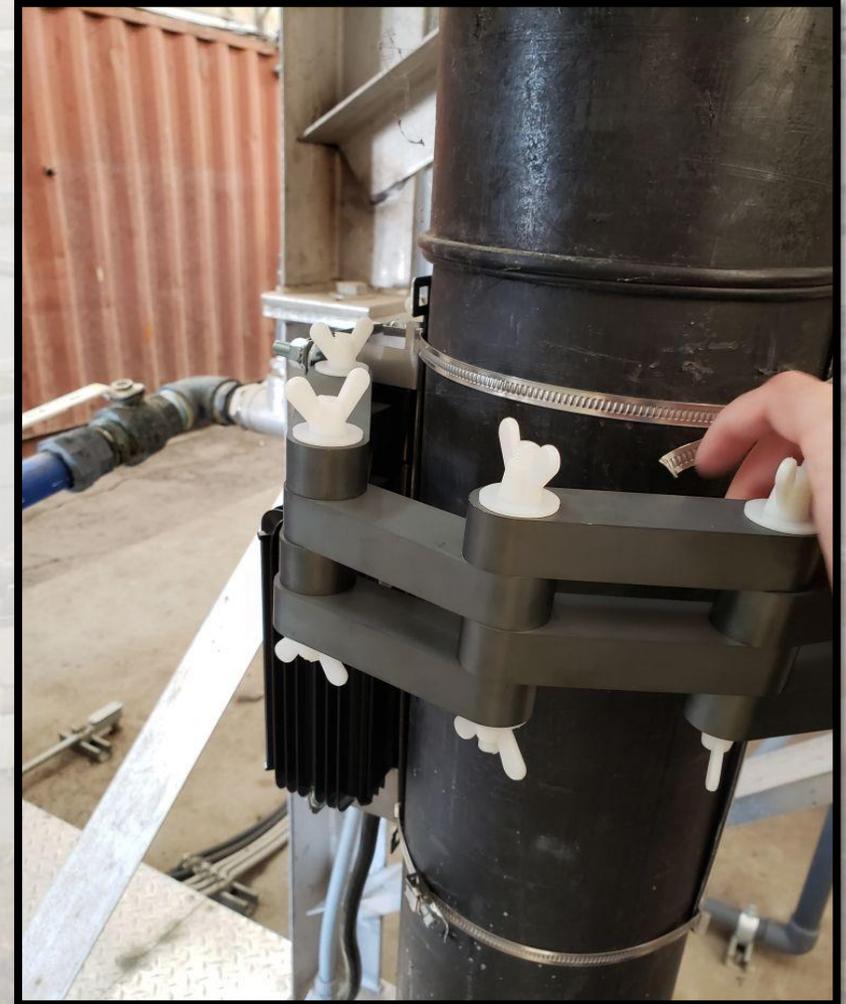
HydroFLOW Custom i8" Unit

On September 26th, 2023, a Custom *HydroFLOW* i8" unit was installed on the sludge line feeding one of the screw presses.

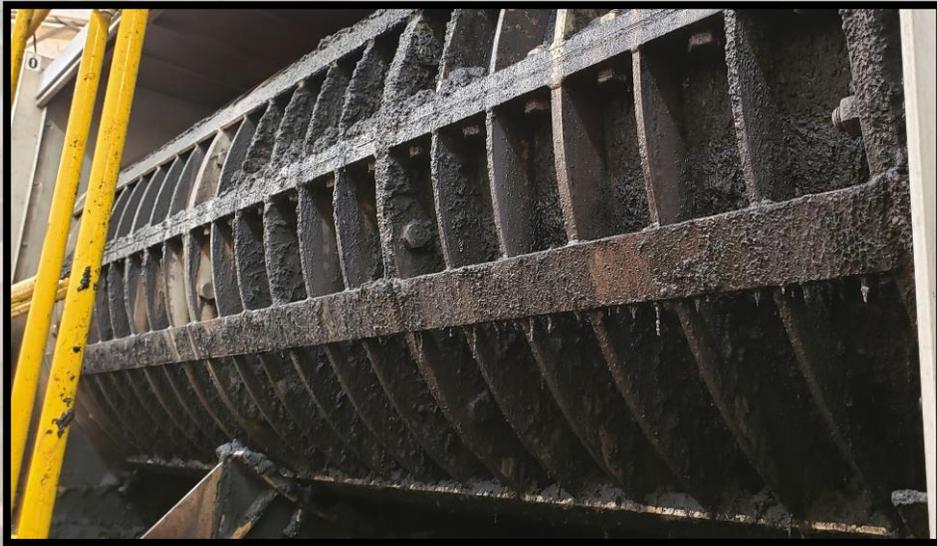
Soft Struvite buildup inside the screw press

Rather than gradually reducing chemical usage, the plant chose to discontinue chemical usage to evaluate how *HydroFLOW* would perform on its own. After 30 days, the press did not require cleaning, and only had a little mud-like Struvite accumulation. After 60 days, the press was pressure washed, taking less than 4 hours to complete instead of the typical 30 hours with chemicals. The reduction of chemical usage and time saved in manual cleaning led to a 3-month payback period.

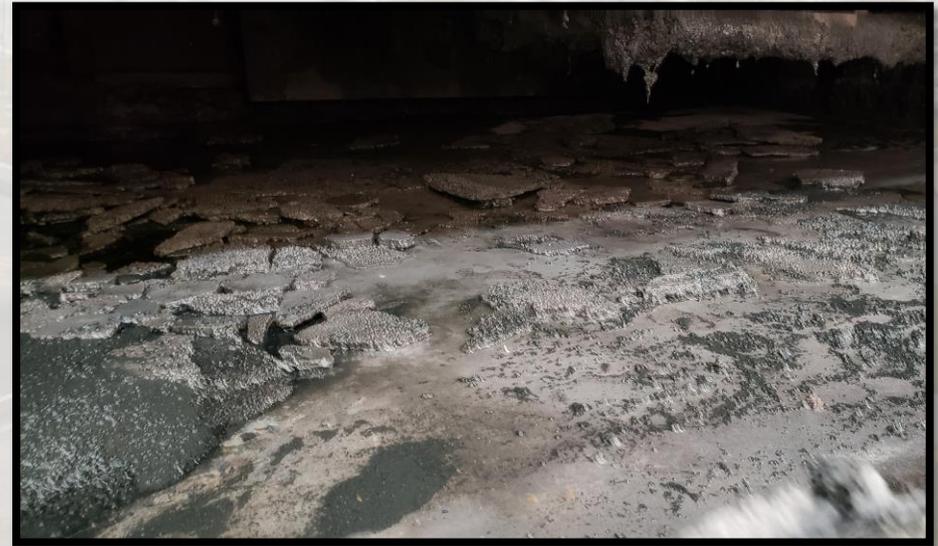
Sheets of soft Struvite that easily washed off the screw press during cleaning
