***HydroFLOW* Cooling Tower Inspection Report**

Nellis Air Force Base

Updated on June 26, 2019

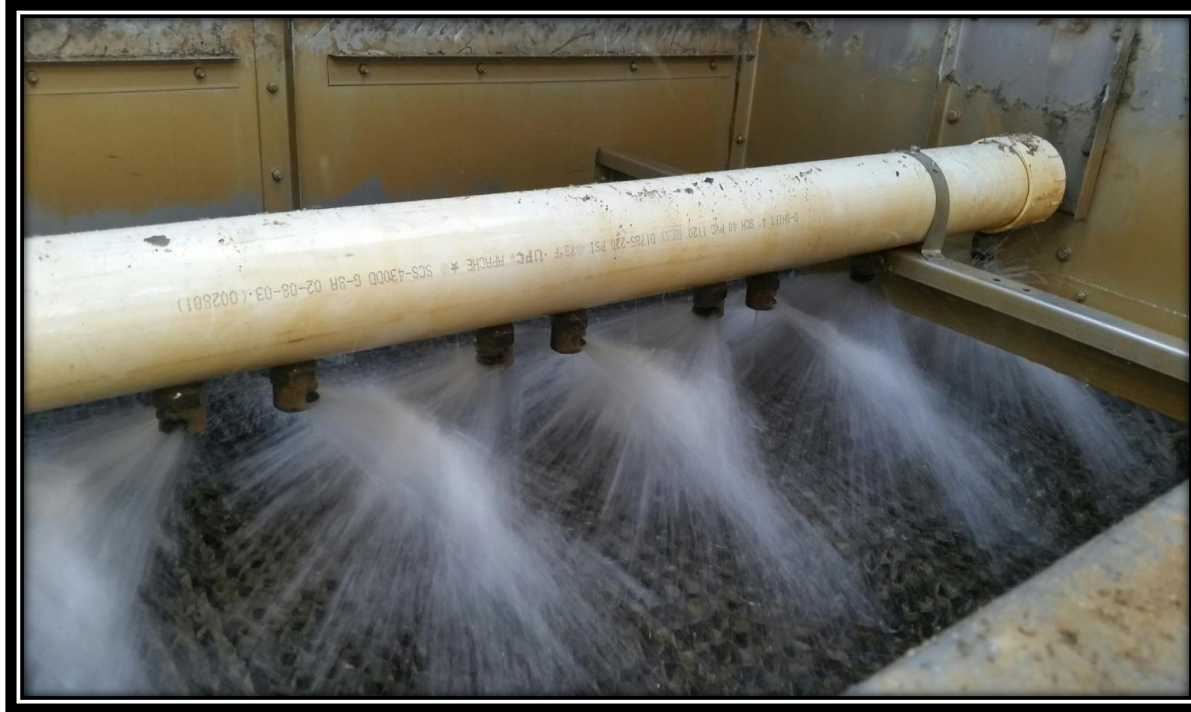
Due to equipment malfunction, the cooling tower's conductivity meter read 14,000 μ S, which was 6 times too high. Airman Payne repaired the damaged system and reset the controller back to the normal operational parameters of 2,300 μ S. No significant hard scale or bio buildup was observed on the nozzles or infrastructure.

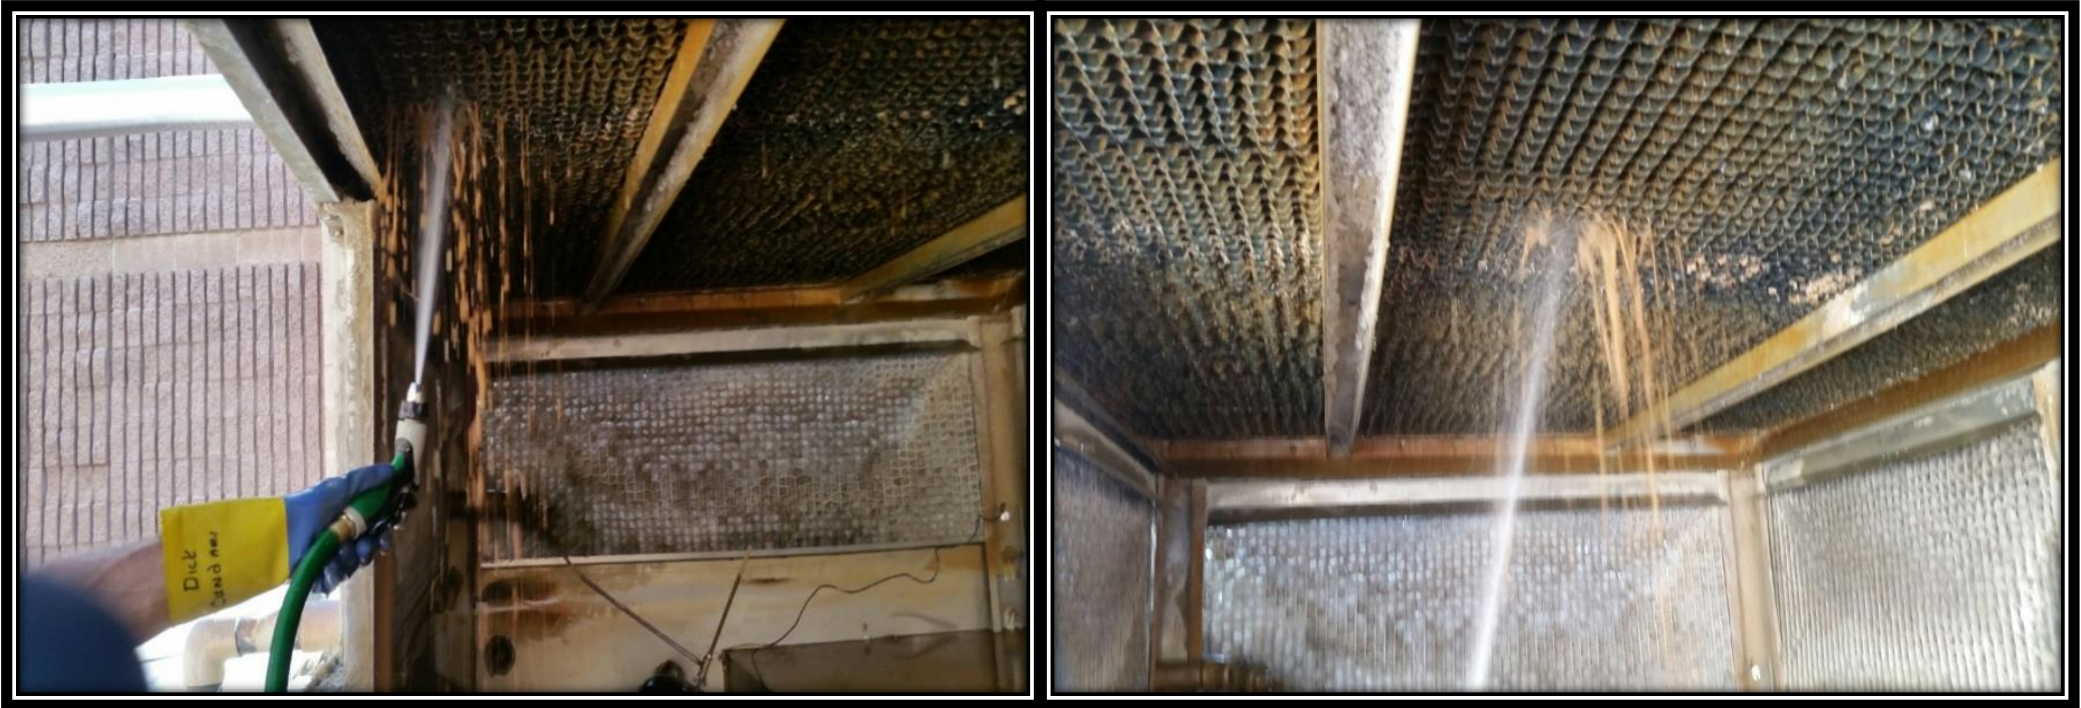
Instead of the hard scale that typically accumulates inside the cooling tower, loose brown mud-like material was found. A garden hose was used to easily remove the mud-like substance from the fill material and the drift eliminators.

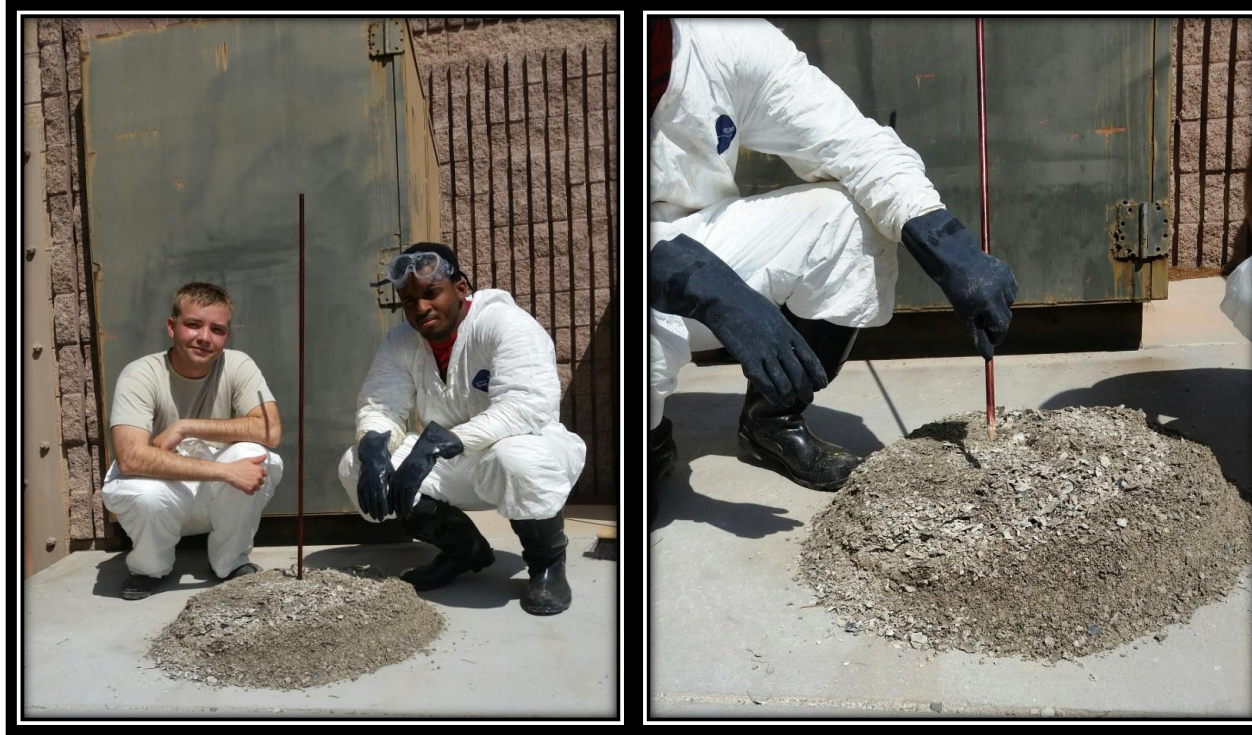
Senior Airman Buckanan and Airman Payne pictured next to the scale that was removed from the drift eliminators. The pile measured 30” in circumference at the base and 24” at the top, the depth was approximately 6”.

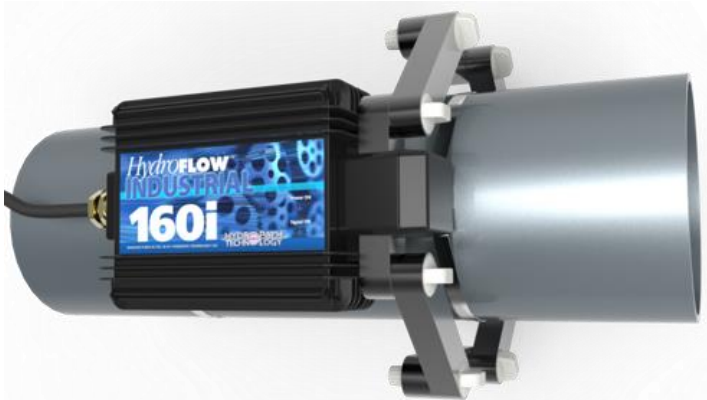
A *HydroFLOW* model 160i was installed on cooling tower 11. During the month of March 2019, a *HydroFLOW* representative inspected the cooling tower and 160i - both were in excellent operating condition. For additional information, please contact Mike Colton from *HydroFLOW* West (mike@hydroflowwest.com)
