HydroFLOW Reduces Algae Growth in Vineyard Irrigation Pond

Customer: California vineyard that suffers from severe algae growth in its irrigation ponds, which causes maintenance problems in the filtration stations.

Objective: Reduce algae growth without the use of Copper Sulfate or Tilapia fish.

Duration: Five month product evaluation from May 1, 2015 to October 26, 2015.

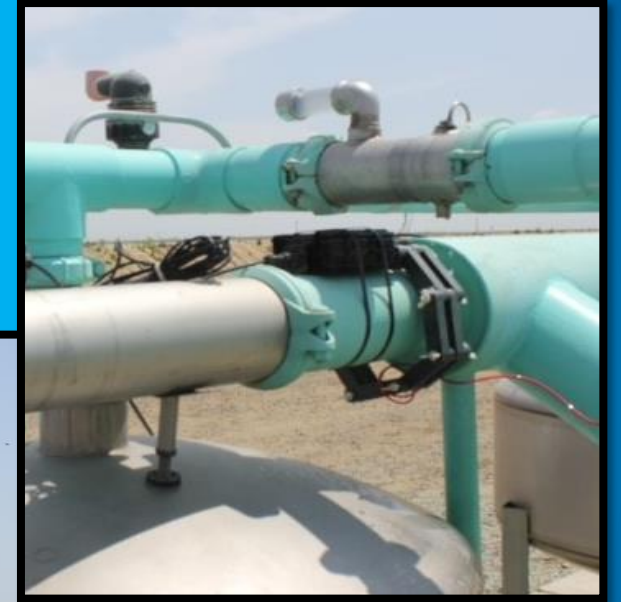
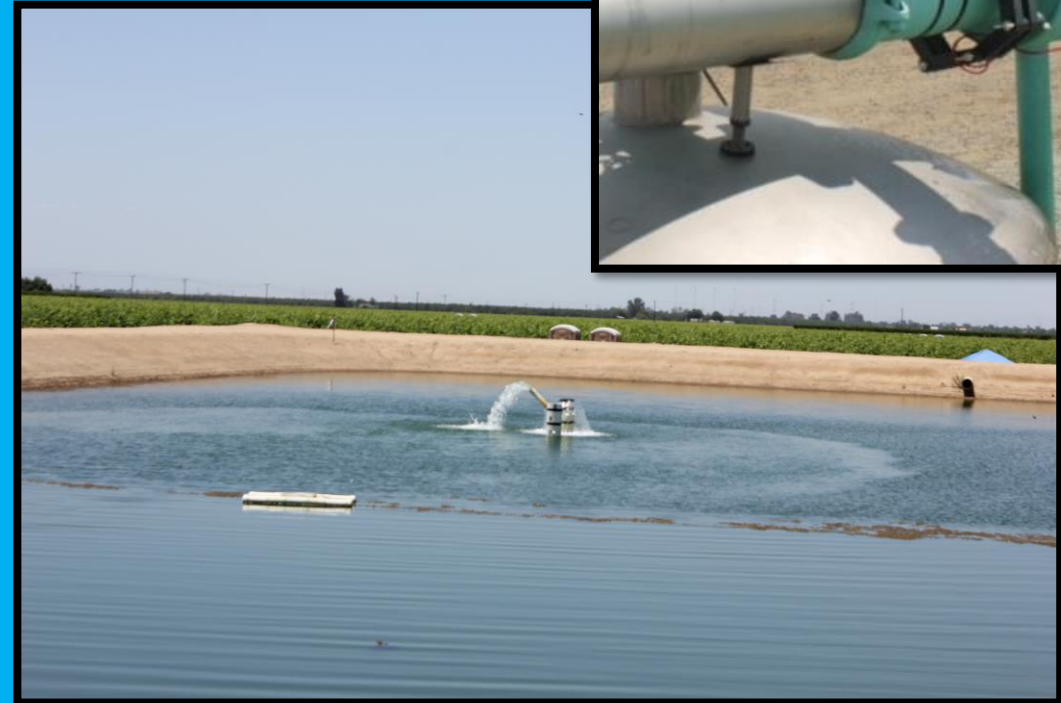
The vineyard controls algae growth in their ponds with the addition of Copper Sulfate (fungicide/algaecide) or Tilapia fish (algae consumers)

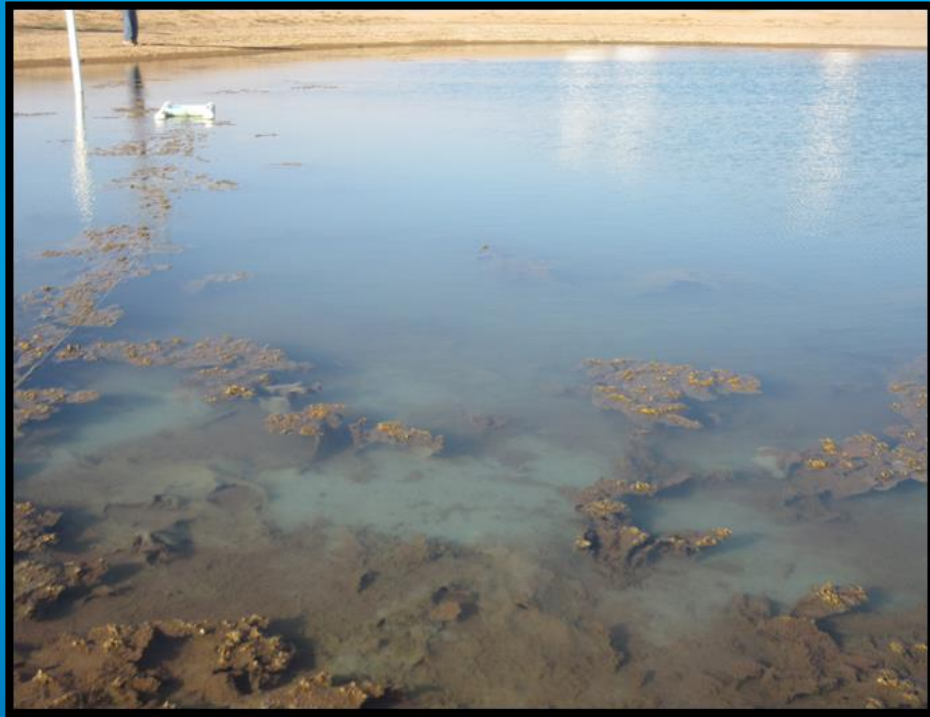
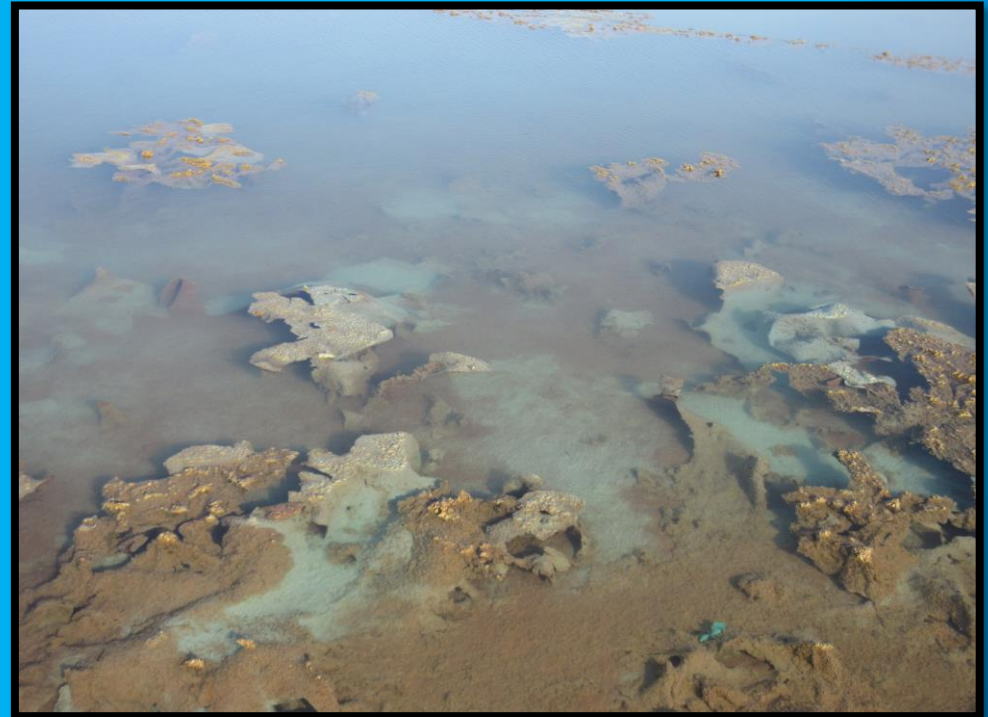
Algae growth continues to be a nuisance, even with the introduction of Copper Sulfate or Tilapia fish.

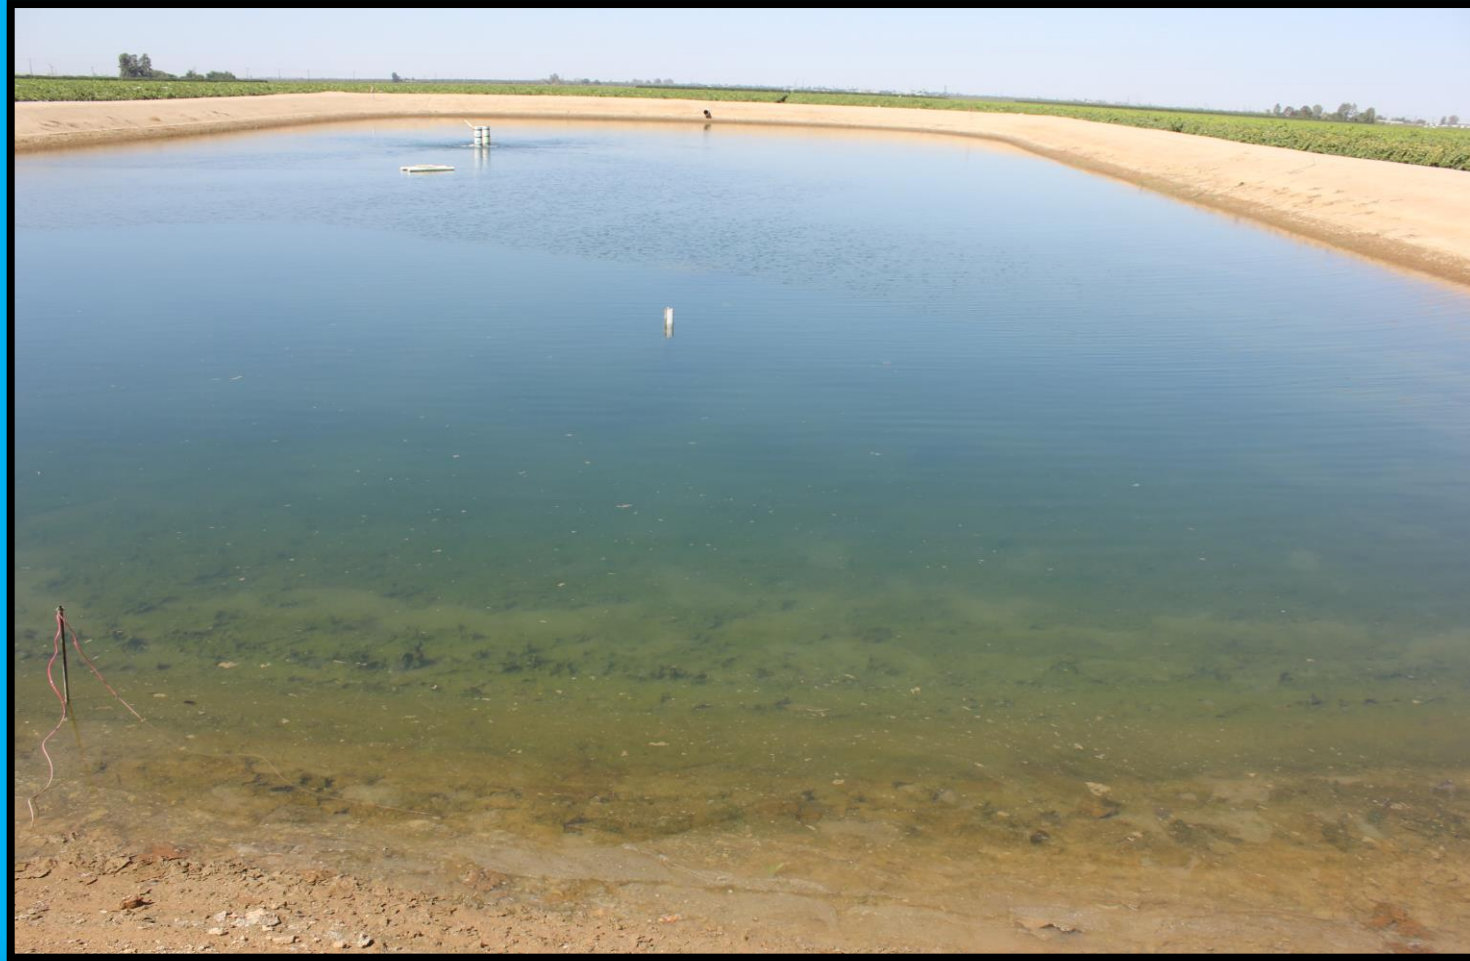
Two months with *HydroFLOW* and without the addition of Copper Sulfate or Tilapia fish

With *HydroFLOW* the reduction in algae growth was dramatic.

- *HydroFLOW* retained algae growth within desired levels.
- Compared to the Copper Sulfate and Tilapia fish algae treatment methods, the bacteria and algae CFU counts in the *HydroFLOW* treated pond were over 90% lower.
- Savings associated with lessened chemical usage, reduced backwash and reduced maintenance costs resulted in an estimated 1.5 year return on investment.

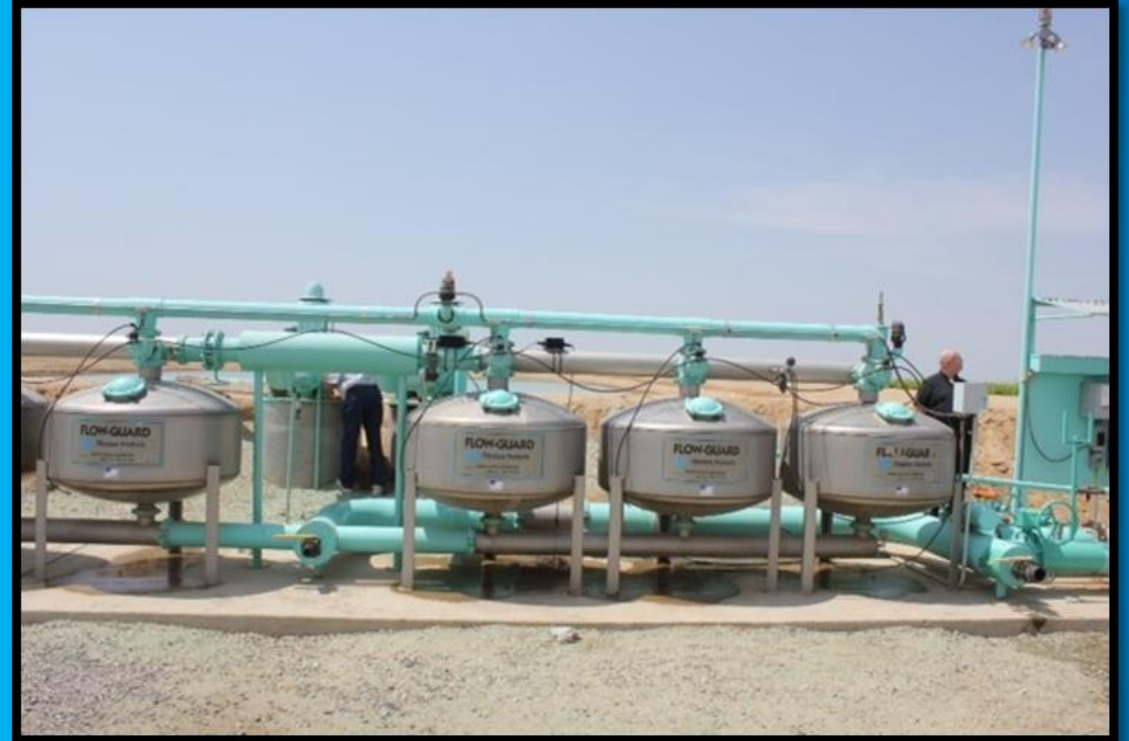
Impact on the pond's filtration station

- Before the installation of *HydroFLOW*, the backwash process took 10-15 minutes.
- After the installation of *HydroFLOW*, the backwash process took 3-5 minutes.
